<u>MANDATORY SERVICE BULLETIN NO.</u> MSB 40-103 / MSB F4-042 / MSB D4-114 / MSB 40NG-084 <u>REV. 2</u>

Type: DA 40 / DA 40 D / DA 40 F / DA 40 NG

I.5 Subject

Actions to prevent Passenger Door Separation: Installation of Placards, AFM Procedure update and Inspection/Data Gathering.

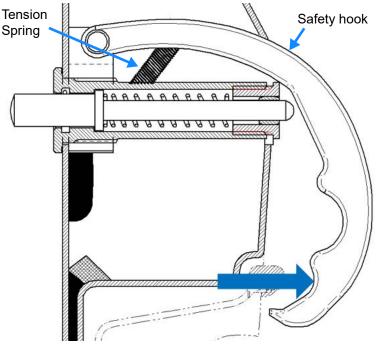
- Check the condition of the tension spring and the force to lift the safety hook from its resting position as follows: Refer to Figure 2.
 - a) Open the passenger door.

- b) Examine the tension spring of the safety hook. Use a borescope through cutout in the door, if corrosion, deformation or damage if found, take note and replace it after this WI is completed. Refer to Section IV for removal and installation of the hook assembly.

- 4) If correction/replacement of any part is required, take notes and do it after this WI is completed. Refer to Section IV for removal and installation of the hook assembly.

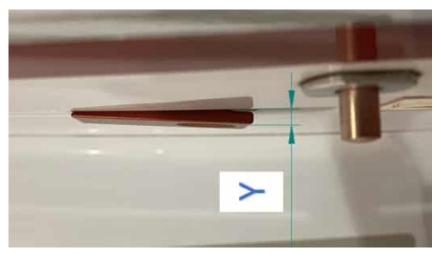
Figure 11. Protrusion measurement

19. Data collection: Position of the external passenger door handle. Refer to Figures 11 and 12.

- a) Close the passenger door.
- b) Push the external passenger door handle into the latched position until it stops.
- c) Examine if the passenger door handle is recessed, flush or protruding over the passenger door surface.
- d) Record the condition of the passenger door handle on the execution report in Appendix A.
- e) If the handle protrudes from the surface of the passenger door, measure the protrusion.
- f) Record the measurement on the execution report in Appendix A.

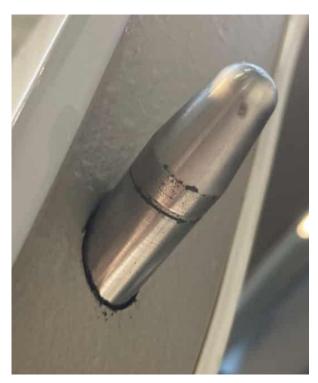
Figure 14. Example of serviceable latching bolt

- 21. Examine the latching bolts of the passenger door for looseness, excessive play, wear, corrosion and poor condition. Refer to Figure 14.
 - It must not be possible to rotate the latching bolts by hand force.

- If the radial play is greater than 0.8 mm, contact Diamond Aircraft Industries Inc.
 - No signs of corrosion is allowed.
 - If you find signs of corrosion on the latching bolts, take note and replace the latching bolts after the WI is completed. Refer to AMM 52-10 for replacement.

- No deformation (dents, bends, cracks) on the latching bolts is allowed.
 - If deformations of the latching bolts are found, take note and replace the latching bolts after the WI is completed. Refer to AMM 52-10 for replacement

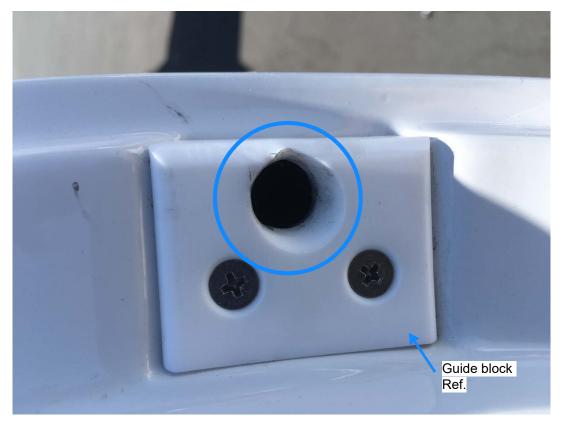
Figure 18. Example of NOT acceptable condition of door guide block

23. Inspect the front and rear door guide block for damage. Refer to Figure 18.

- a) Open the passenger door.
- b) Visually check the condition of the guide block.
 - The guide block must not have worn edges, dents, cracks.
 - If you found any damage, take note and replace the guide block after the WI is completed. Refer to section IV for the replacement.
 - Record any damage of the guide blocks on the execution report in Appendix A.

- 1. Remove the 2 screws that attach the guide block and remove it from aircraft.
- 2. Install new guide block (item 20 and/or 21) with 2 screws (item 22). Use Loctite 241 or 243 (item 7 or 7a) to screw, refer to manufacturer instructions for proper use.
- NOTE: Use new screws or make sure the existing screws are in serviceable condition and cleaned before you apply threadlocker and reinstall them.
 - 3. Record the replacement of the guide blocks on the execution report in Appendix A.
- NOTE: It is allowed to grind the guide block hole up to 5 mm if required to align with the latching bolt.
