**OPTIONAL SERVICE BULLETIN NO. OSB D4-115 REV. 0**

Type: DA 40 D

S/N: D4.188 and prior.

Vertical stabilizer rivet nuts replacement by anchor nuts.

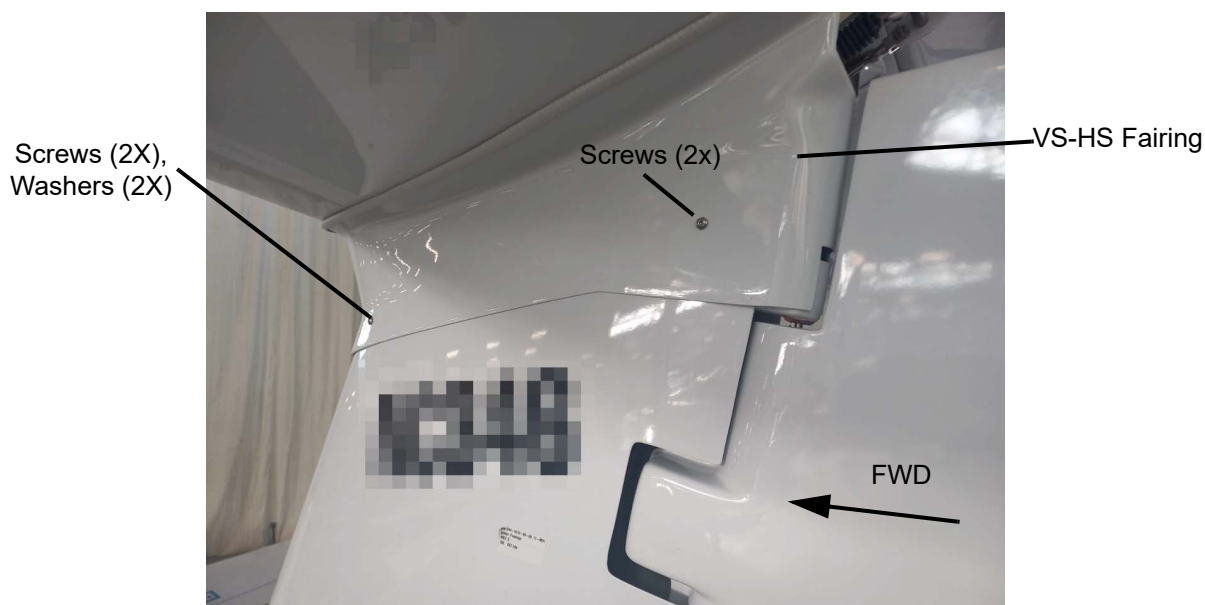
Figure 1. VS-HS fairing removal.

The V-stab to H-stab fairing is attached to V-stab at the trailing edge attachment points using rivet nuts. These rivet nuts are installed into V-stab composite structure. If these rivet nuts are not properly secured, they may disengage from the V-stab structure. This condition may lead to vibration in the tail-plane, affecting vertical and horizontal stability.

1. Remove the 4 screws and 2 washers which attach the VS-HS fairing. Refer to Figure 1.

2. Remove the VS-HS fairing from the airplane.
3. Do an inspection of the V-stab to H-stab trailing edge attachment points on the V-stab.
