SERVICE INFORMATION NO. SI D4-046

GTX 327 or GTX 32 Software upgrade
ATA-Code: 34-00

NO.: 0545

SUBJECT: GTX 327, GTX 32 Software Upgrade to Version 2.09 for non-G1000 applications only

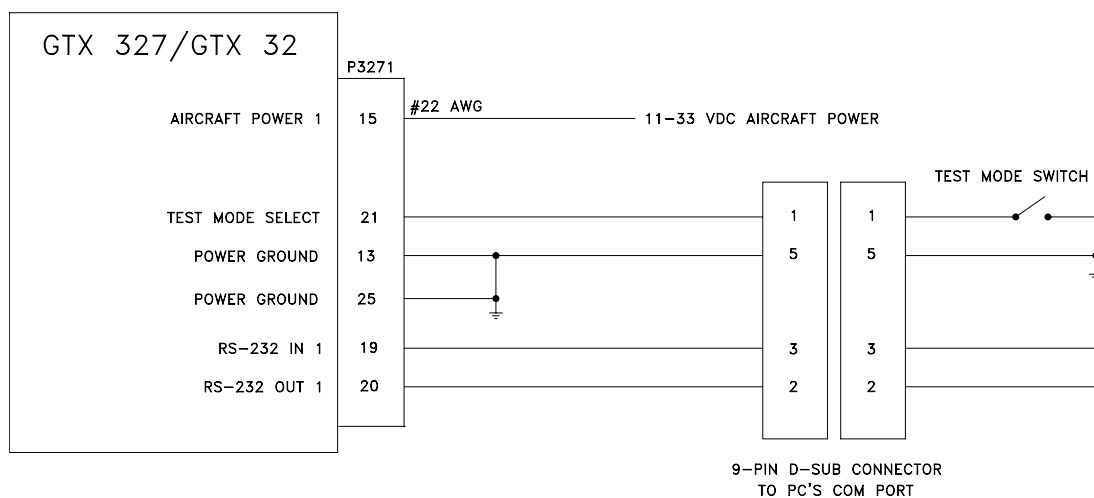
1. Assemble a test harness for the GTX 327/32 as shown in the following figure:
