## SERVICE INFORMATION NO. SI D4-073/1

GARMIN Service Alert 070801-01  
ATA-Code: 34-00

**Service Alert: 070801-01**

#### **REVISION B: Revised Affected Products and Aircraft Section**

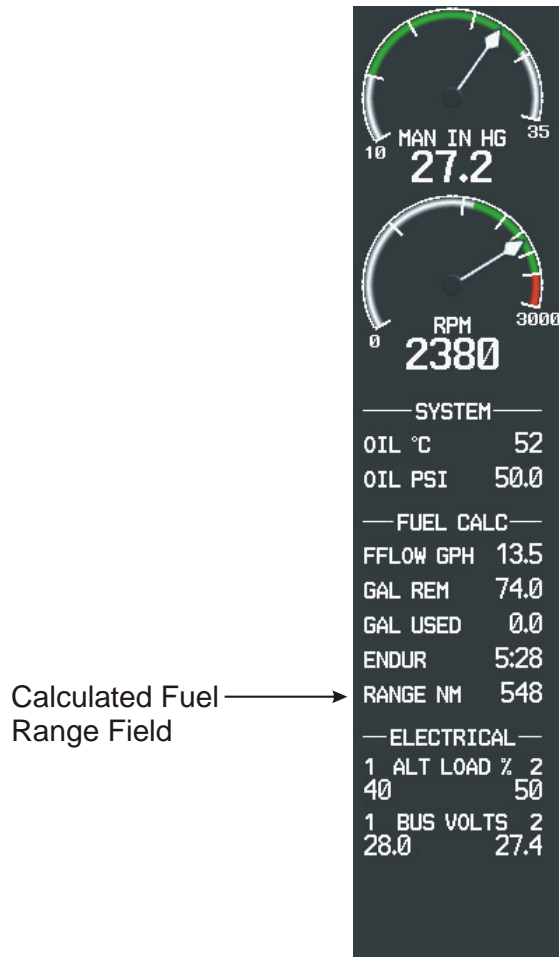
**Figure 1. Engine System Display (Typical)**

Affected aircraft use a Calculated Fuel Range Field (Figure 1) that works correctly only when the Distance/Speed Display Unit Field on the AUX - System Setup Page is set to NAUTICAL (NM, KT) (Figure 2).

When the Distance/Speed setting on the AUX System Setup Page is changed to METRIC (KM, KPH), the Calculated Fuel Range Field on the Engine System Display is inaccurate. This may cause the pilot to mistakenly believe he can fly farther than is possible on the remaining fuel.

GDU software V8.20 or later incorporates a change correcting the issue. Until GDU software V8.20 or later is installed, the pilot should select NAUTICAL (NM, KT) Display Units for Distance/Speed on the AUX System Setup Page (Figure 2). Instructions on changing the Distance/Speed Units are in the Pilot's Guide and Cockpit Reference Guide for the aircraft listed in this Service Alert.
