SERVICE INFORMATION NO. SI D4-091/1

EASA EAD No. 2008-0027-E

Thielert Service Bulletin TM TAE 125-1005 P1 Bracket HP Line HPP-Fuel Rail, Rev. 1

Technische Mitteilung / Service Bulletin**PRIORITY 1 – Safety**

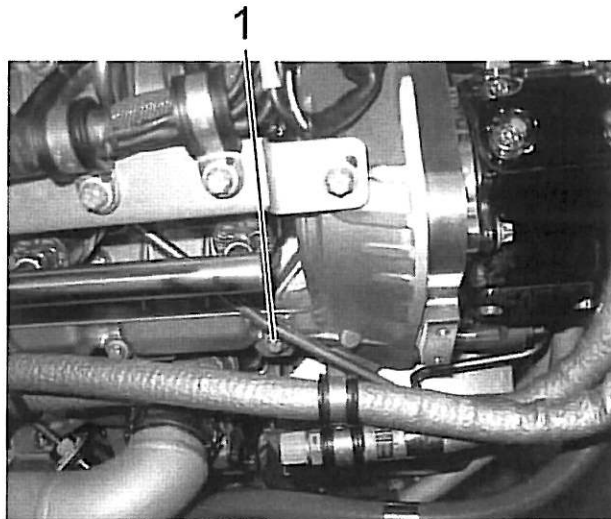
Bild 1 / Fig. 1

- 1 Schraube /
Screw

1. Detach the screw of the cylinder head cover. See Fig. 1.
2. Attach the spacer to the cylinder head cover. See Fig. 3.

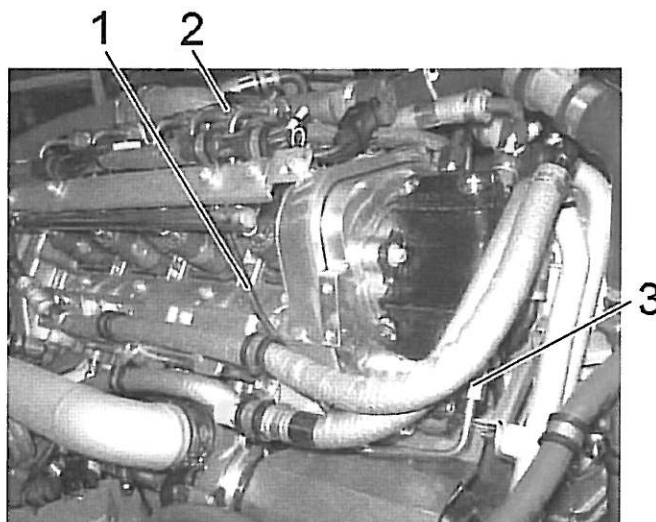
Bild 2 / Fig. 2

Reason: *Because of possible fractures by vibration on the High-Pressure Fuel Line, the following work sequences must be accomplished.*

- 1 Kraftstoffhochdruckleitung /
High-Pressure Fuel Line
2 Überwurfmutter Fuel Rail (SW18) /
Union Nut Fuel Rail (wrench size 18mm)
3 Überwurfmutter Hochdruckpumpe (SW14) /
Union Nut High-Pressure Pump (wrench size 14mm)

3. Remove the high-pressure fuel line. See Fig. 2.

9. Tighten the union nuts of the high-pressure fuel line. See Fig. 2.

Union nut high-pressure pump (wrench size 14mm): 22 Nm

Union nut fuel rail (wrench size 18mm): 27 Nm

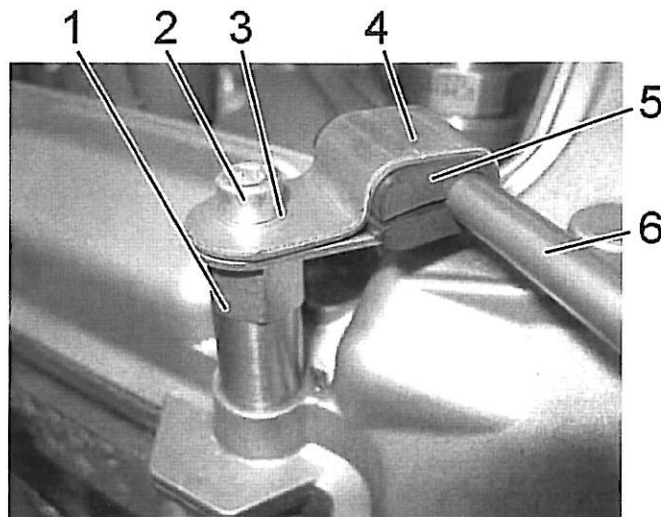
Bild 3 / Fig. 3

- 1 Abstandshalter /
Spacer
- 2 Schraube /
Screw
- 3 Scheibe /
Washer
- 4 Halter /
Fastener
- 5 Beilage /
Insert
- 6 Kraftstoffdruckleitung /
High-Pressure Fuel Line

5. Attach the fastener and the insert to the high-pressure fuel line. See Fig 3.
6. Attach the fastener to the spacer using one bolt and one washer. See Fig. 3.

8. Tighten the screw of the fastener. See Fig. 3.

7 Nm
