SERVICE INFORMATION NO. SI D4-096

Garmin G1000 System: Transponder Flight Identification Operation
ATA-Code: 34-00

NO.: 0806 Revision A

TO: All Garmin G1000 Customers
DATE: 14 March 2008
SUBJECT: G1000 Transponder Flight Identification Operation

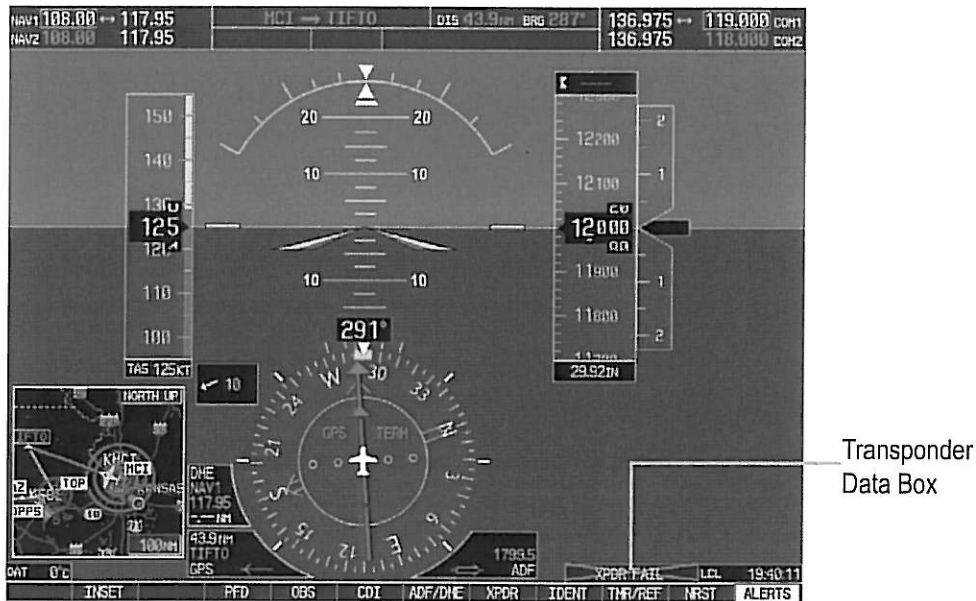
Figure 2 – Transponder Data Box

If the Transponder Data Box (Figure 2) is marked with a red “X” after entering or changing a Flight ID number, perform the following:

For dual transponder installations:

1. Pull the associated transponder circuit breaker to prevent transmitting an incorrect Flight ID number and/or transponder code
2. Select the opposite transponder using the PFD softkeys.
3. Contact your maintenance organization to service the transponder.

For single transponder installations:

- If airborne, advise Air Traffic Control of a possible transponder failure and follow ATC instructions for continued operation of the transponder.
- If on the ground, contact your maintenance organization to service the transponder.

Maintenance personal should refer to the airframe’s G1000 System or Line Maintenance Manual for instructions on how to reconfigure the transponder.
