## SERVICE INFORMATION NO. SI D4-098

Garmin G1000 System: Transponder Flight Identification Operation  
ATA-Code: 34-00

NO.: 0806 Revision B

TO: All Garmin G1000 Customers  
DATE: 18 March 2008  
SUBJECT: G1000 Transponder Flight Identification Operation  
REVISION B: Removed GDU software version number

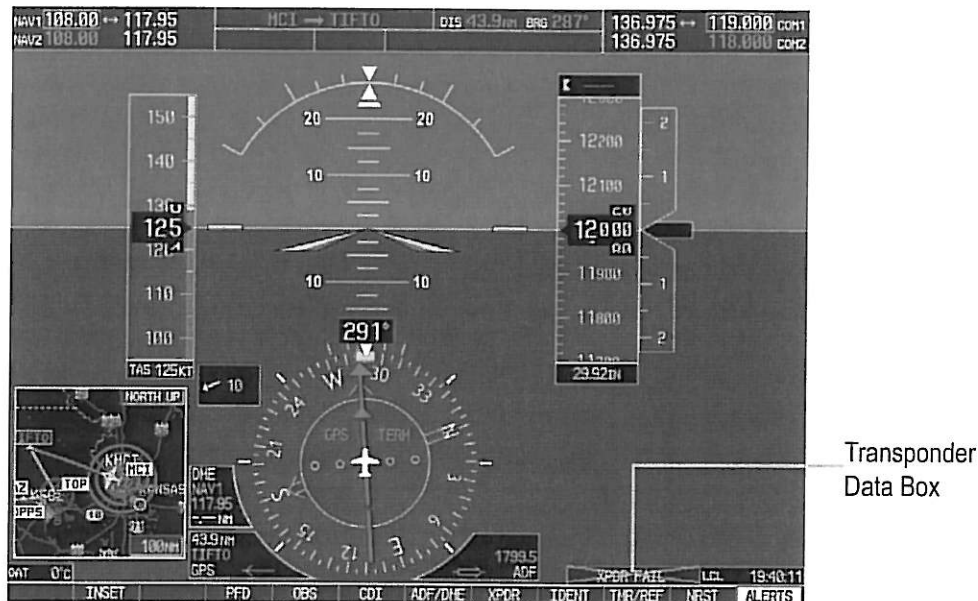
**Figure 2 – Transponder Data Box**

Garmin has identified an issue that is infrequently encountered when entering or changing a G1000 Transponder Flight Identification (ID) number using the Primary Flight Display (PFD) entry method. This issue may cause the following to appear on the PFD:

- A red "X" (failure indication) on the Transponder Data Box
- A "XPDR Config Service" message in the Message Box

If the Transponder Data Box (Figure 2) is marked with a red “X” after entering or changing a Flight ID number, perform the following:

For dual transponder installations:

1. Pull the associated transponder circuit breaker to prevent transmitting an incorrect Flight ID number and/or transponder code
2. Select the opposite transponder using the PFD softkeys.
3. Contact your maintenance organization to service the transponder.

For single transponder installations:

- If airborne, advise Air Traffic Control of a possible transponder failure and follow ATC instructions for continued operation of the transponder.
- If on the ground, contact your maintenance organization to service the transponder.

Maintenance personal should refer to the airframe's G1000 System or Line Maintenance Manual for instructions on how to reconfigure the transponder.
