## SERVICE INFORMATION NO. SI D4-107

GARMIN – Service Bulletin No. 0823  
ATA-Code: 34-00

**SUBJECT:** GDU 104X CRS/BARO Knob Interference

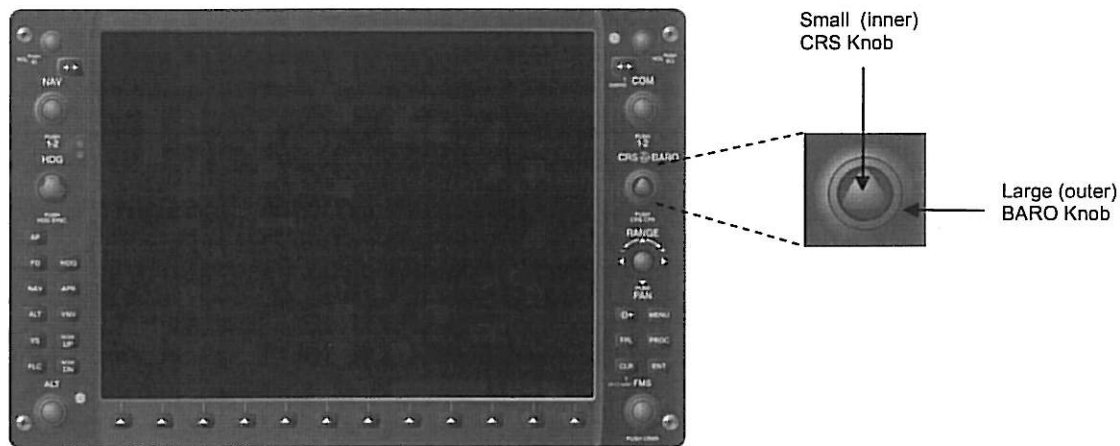
**Figure 1**

Garmin has identified an issue, whereby the large (outer) BARO knob and the small (inner) CRS knob may interfere with each other.

1. Apply power to the G1000/G900X/G950.
2. Press the CDI softkey on the Primary Flight Display(s) (PFD) to enter VOR mode on the HSI.
3. Rotate the large (outer) BARO knob (refer to Figure 1) a minimum of three complete revolutions in each direction while monitoring the Horizontal Situation Indicator/Digital Course Indicator (refer to Figure 2) on the PFD. If a change in the Horizontal Situation Indicator/Digital Course Indicator is produced while turning the BARO knob proceed to the Modification Instructions.

4. Rotate the small (inner) CRS knob (refer to Figure 1) a minimum of three complete revolutions in each direction while monitoring the Barometric Altimeter Setting (refer to Figure 2) on the PFD. If a change in the Barometric Altimeter Setting is produced while turning the CRS knob proceed to the Modification Instructions.
5. Repeat Steps 3 and 4 for each affected GDU.
