## SERVICE INFORMATION NO. SI D4-107

GARMIN – Service Bulletin No. 0823  
ATA-Code: 34-00

**NO.: 0823**

**SUBJECT:** GDU 104X CRS/BARO Knob Interference

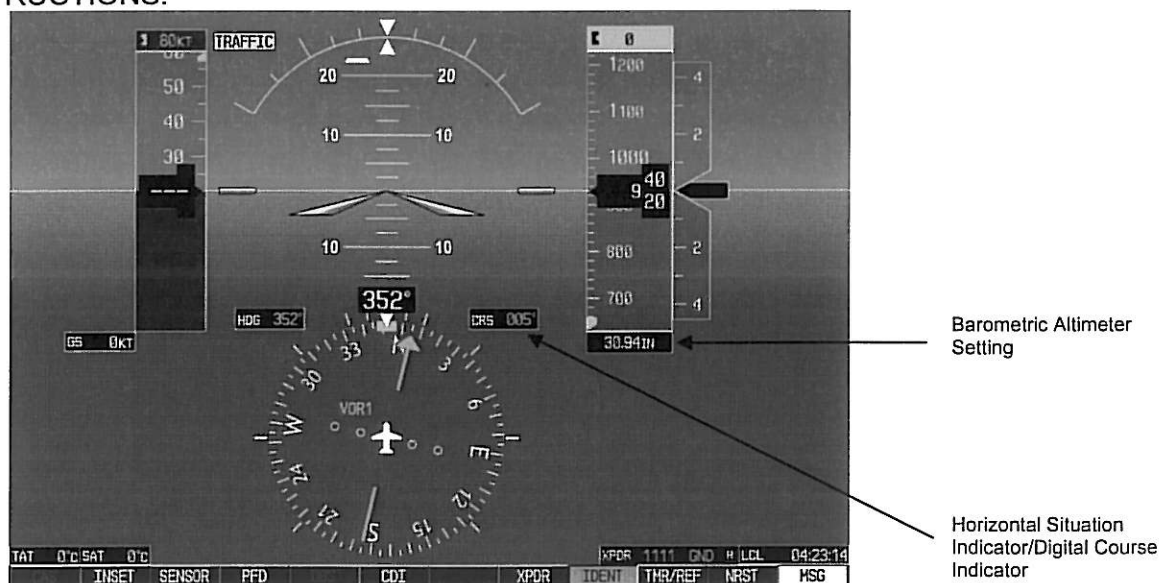
Figure 2

4. Rotate the small (inner) CRS knob (refer to Figure 1) a minimum of three complete revolutions in each direction while monitoring the Barometric Altimeter Setting (refer to Figure 2) on the PFD. If a change in the Barometric Altimeter Setting is produced while turning the CRS knob proceed to the Modification Instructions.
5. Repeat Steps 3 and 4 for each affected GDU.
