SERVICE INFORMATION NO. SI D4-108

GARMIN Service Alert No. 0824
ATA-Code: 34-00

**** MANDATORY **
SERVICE BULLETIN**

SUBJECT: GDU 104X CRS/BARO Knob Interference

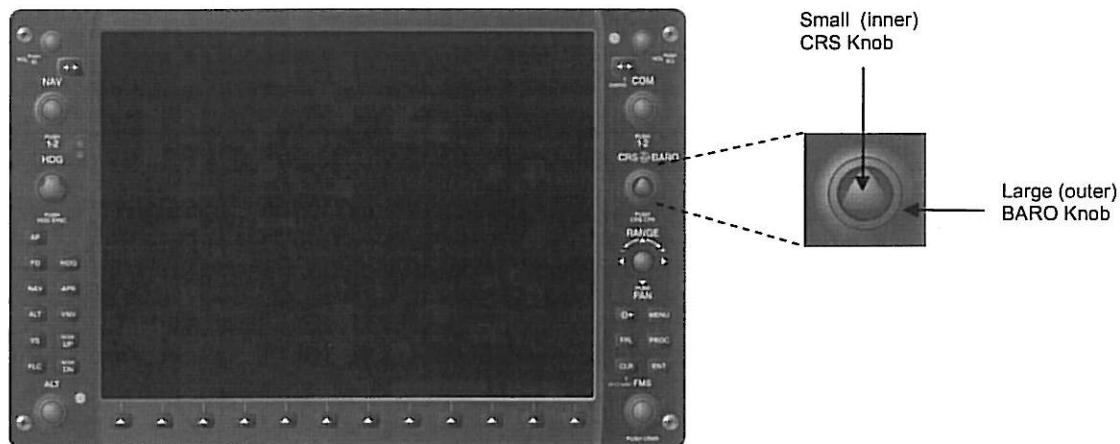
Figure 1

Garmin has identified an issue, whereby the large (outer) BARO knob and the small (inner) CRS knob may interfere with each other.

1. Apply power to the G1000/G900X/G950.
2. Press the CDI softkey on the Primary Flight Display(s) (PFD) to enter VOR mode on the HSI.
3. Rotate the large (outer) BARO knob (refer to Figure 1) a minimum of three complete revolutions in each direction while monitoring the Horizontal Situation Indicator/Digital Course Indicator (refer to Figure 2) on the PFD. If a change in the Horizontal Situation Indicator/Digital Course Indicator is produced while turning the BARO knob proceed to the Modification Instructions.

4. Rotate the small (inner) CRS knob (refer to Figure 1) a minimum of three complete revolutions in each direction while monitoring the Barometric Altimeter Setting (refer to Figure 2) on the PFD. If a change in the Barometric Altimeter Setting is produced while turning the CRS knob proceed to the Modification Instructions.
5. Repeat Steps 3 and 4 for each affected GDU.

If CRS/BARO Knob interference is confirmed, perform the steps below to replace the CRS/BARO Knob. New knobs can be obtained through a Garmin Service Center or Aircraft OEM under Garmin part number K00-00446-00.

1. Grasp the small (inner) CRS knob and firmly pull the knob off the shaft.
2. Discard knob.
3. Grasp the large (outer) BARO knob and firmly pull the knob off the shaft.
4. Discard knob.
