SERVICE INFORMATION NO. SI D4-108

GARMIN Service Alert No. 0824
ATA-Code: 34-00

NO.: 0824

TO: All G1000/G900X/G950 Owners and Operators
DATE: 10 July 2008
SUBJECT: GDU 104X CRS/BARO Knob Interference

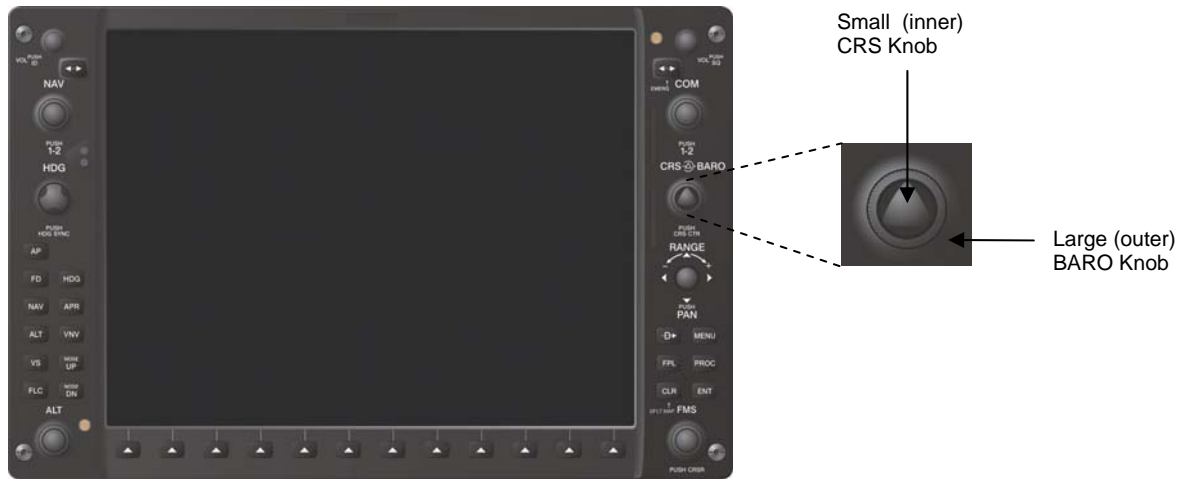
Figure 1

Garmin has identified an issue, whereby the large (outer) BARO knob and the small (inner) CRS knob may interfere with each other.

1. Apply power to the G1000/G900X/G950.
2. Press the CDI softkey on the Primary Flight Display(s) (PFD) to enter VOR mode on the HSI.
3. Rotate the large (outer) BARO knob (refer to Figure 1) a minimum of three complete revolutions in each direction while monitoring the Horizontal Situation Indicator/Digital Course Indicator (refer to Figure 2) on the PFD. If a change in the Horizontal Situation Indicator/Digital Course Indicator is produced while turning the BARO knob contact your local Garmin Service Center or OEM Dealer to replace the knobs.
