SERVICE INFORMATION NO. SI D4-110

GARMIN – Service Bulletin No. 0823 Rev. B
ATA-Code: 34-00

NO.: 0823 Rev B

SUBJECT: GDU 104X CRS/BARO Knob Interference

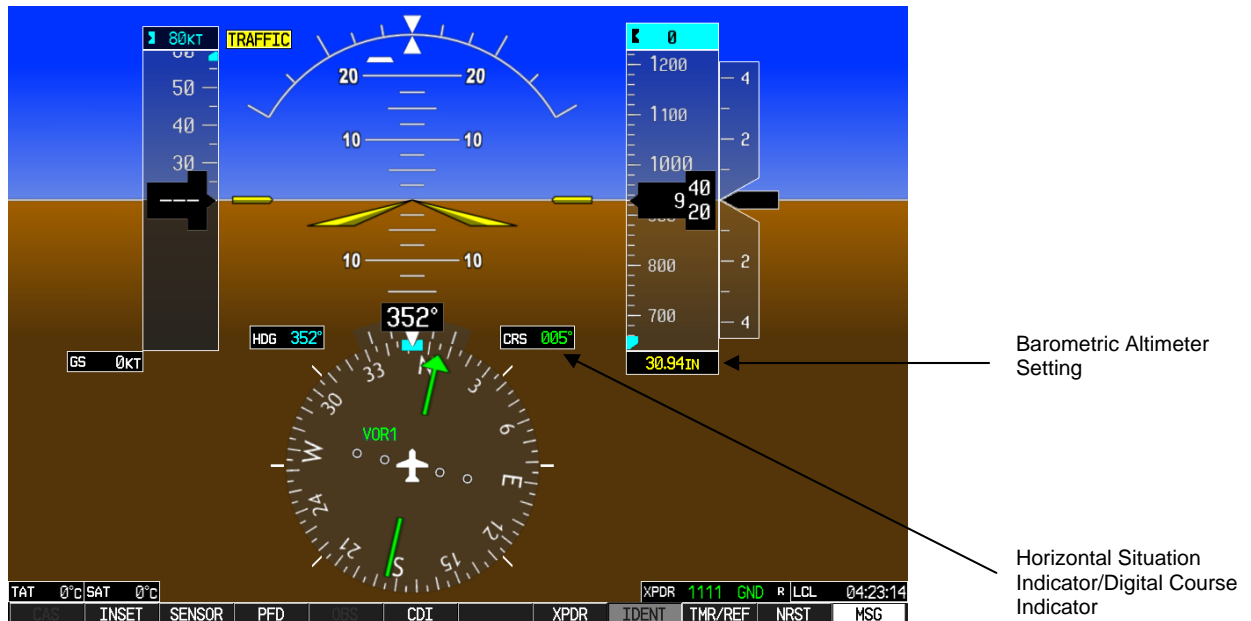
Figure 3

4. Rotate the small (inner) CRS knob (refer to Figure 1) a minimum of three complete revolutions in each direction while monitoring the Barometric Altimeter Setting (refer to Figure 3) on the PFD. If a change in the Barometric Altimeter Setting is produced while turning the CRS knob proceed to the Modification Instructions.
5. Repeat Steps 3 and 4 for each affected GDU.

If CRS/BARO Knob interference is confirmed, perform the steps below to replace the CRS/BARO Knob. New knobs can be obtained through a Garmin Service Center or Aircraft OEM under Garmin part number K00-00446-00.
