## SERVICE INFORMATION NO. SI D4-114

Garmin G1000 System: Transponder Flight Identification Operation  
ATA-Code: 34-00

## SERVICE ADVISORY

**TO:** All Garmin G1000 Customers  
**DATE:** 23 October 2008  
**SUBJECT:** G1000 Transponder Flight Identification Operation  
**REVISION C:** Added GDU software version number

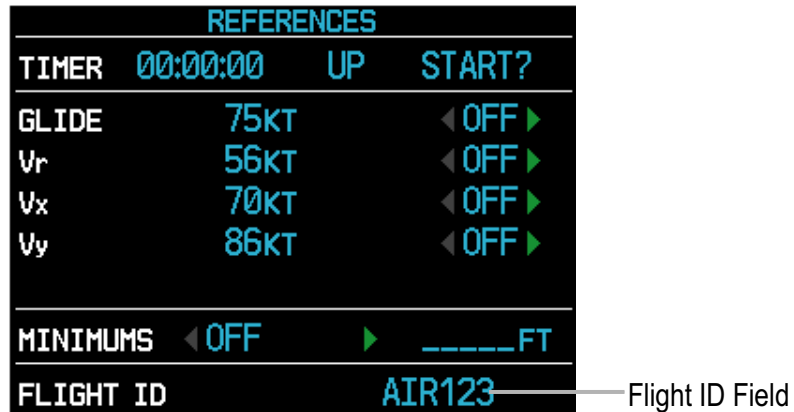
**Figure 1 – PFD Timer Reference Window**

The PFD Entry configuration setting is primarily used outside the continental United States for commercial and/or training operations. Systems with PFD Entry enabled may be readily identified by the presence of a FLIGHT ID field (Figure 1) located at the bottom of the Timer/References Window on the PFD. The Flight ID differs from the 4 digit “squawk” code.
