SERVICE INFORMATION

No. SI D4-175

GARMIN Service Advisory No. 1372 Rev. A

TO: Owners/Operators of all G1000, G2000, G3000, G5000, Cirrus Perspective, Embraer Prodigy, G950, G900X, GNS 400W/500W Series, GTN 650, and GTN 750
DATE: December 16, 2013
SUBJECT: Unavailable RNAV (GPS) approaches due to lack of VDA

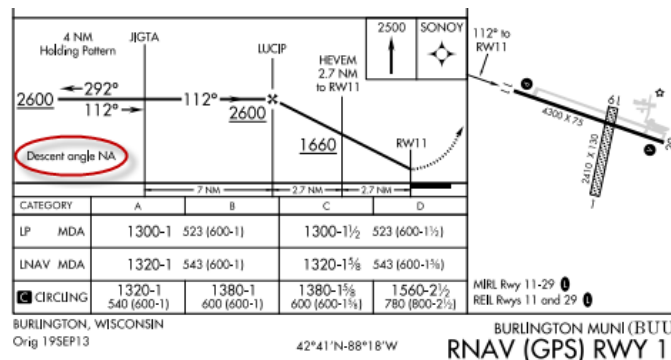
A limited number of RNAV (GPS) approaches, including all service levels, are unavailable for selection when the approach includes LP minima and also has no published vertical descent angle (VDA). See the example in Figure 1.

Figure 1: No Published Vertical Descent Angle (VDA) Example

Pilots must be aware that affected RNAV (GPS) approaches are not available in the list of selectable approaches on the affected navigation systems. The pilot should always accomplish the following actions as part of flight planning activities prior to any IFR flight:

- Use the procedures page/pane on the navigation system to verify availability of procedures for destination airports in your flight plan and/or along your intended route of flight
- Check the Excluded Database Items list on <http://fly.garmin.com> for excluded procedures that may affect your flight
