NO. SI D4-183

Technify Motors Service Bulletin 125-1019 P1 Rev. 1
ATA-Code: 81-00

Service Bulletin No. / Date: SB TMG 125-1019 P1, Revision 1 / September 15, 2015

Subject: Integral Exhaust Manifold

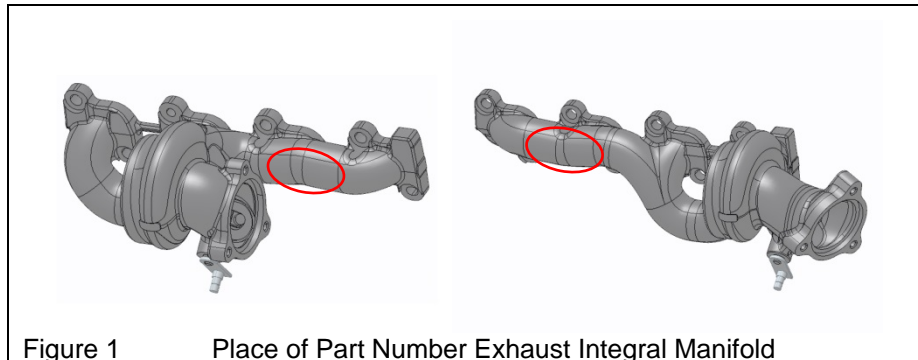
If the engines have Exhaust Integral Manifold
P/N 05-7241-K0176xx or P/N 05-7241-K0178xx
See Figure 1.

Reason: Cases of High Cycle Fatigue (HCF) of turbocharger turbine blades were reported to Technify Motors GmbH.

Installation of exhaust integral manifold P/N 05-7241-K023801 or P/N 05-7241-K023901 in accordance with RM-02-02, Chapter 72-40.03, Issue 3, Revision 2 or later approved revisions.

Installation of exhaust integral manifold P/N 05-7241-K023801 or P/N 05-7241-K023901 in accordance with RM-02-02, Chapter 72-40.03, Issue 3, Revision 2 or later approved revisions and turbocharger P/N 05-7241-K018703, 05-7241-K020302 or 05-7241-K019402 in accordance with RM-02-02, Chapter 72-40.01, Issue 3, Revision 1 or later approved revisions.
