SERVICE INFORMATION LETTER NO. SID4-197

Continental Aerospace Technologies SB CG 125-1028 P1 - Inspection/sealing of the cylinder head side cover.

SB CG 125-1028 P1

Subject: Inspection / sealing of the cylinder head side cover

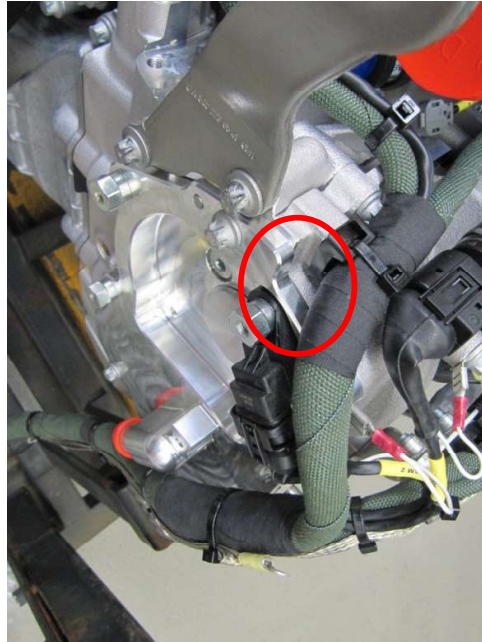
Reason: Possible oil leakage due to an improper sealing of the cylinder head side cover. The oil leak, if not corrected, can result in a damaged v-ribbed belt and possibly an engine shut down.

1. Check the side cover for oil leaks at the marked points. See Figure 1 and Figure 2.

**Sealing of the cylinder head side cover.
To be performed only in the case of an oil leak or the engine is not installed:**
