SERVICE INFORMATION LETTER NO. SID4-198

All DA 40 D aircraft.

Nose landing gear maintenance and inspections.

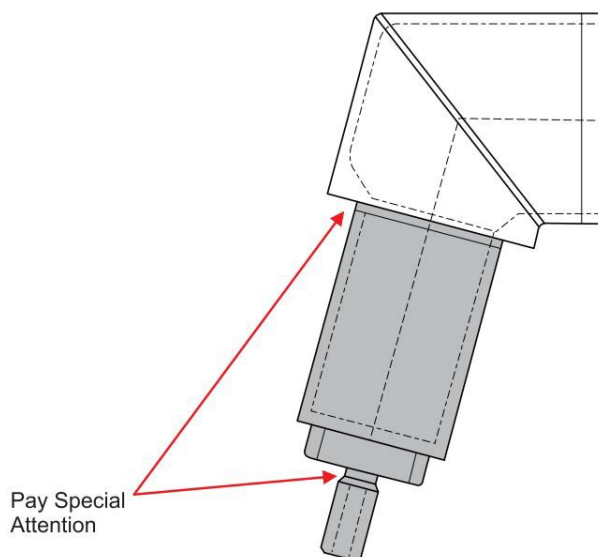
Figure 1. Nose landing gear pivot.

It has been observed that the nose landing gear strut on the DA 40 D aircraft may develop cracks at the top of the pivot or at the top of the stud (see the figure below), which may lead to a nose gear collapse, or the loss of the nose wheel and fork. This service information letter highlights the importance of inspecting the nose landing gear, and highlights updates to the aircraft maintenance manual.

1. D41-3223-10-00_1 and earlier struts are more prone to failure than later designs.
2. A single hard landing may severely reduce the life of a nose gear strut.
3. Improper assembly of the nose gear are major contributors to cracking at the stud, which may result in the loss of the fork assembly.

As there are many environmental and operating conditions that may affect the life of the gear, Diamond Aircraft strongly recommends a thorough check of the nose gear pivot and stud every 100 hr in accordance with AMM Section 05-28-50 and Section 32-20-00, which have been updated with more detailed information regarding the disassembly and assembly of the fork assembly. Details have also been added to Section 05-50-00 for greater clarity during hard landing inspections. It is imperative that all suspected hard landings are reported and the airplane inspected.
