MANDATORY SERVICE BULLETIN

MSB 42MNG-006

Type: DA 42 M-NG

Installation of an additional wire for the alternator fail relay.

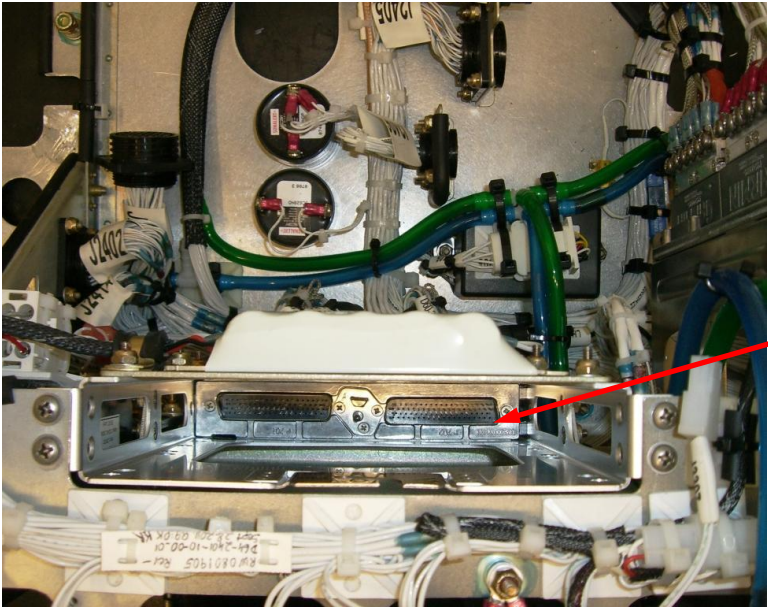
11	<p>Insert the pin of wire 31010A22 into connector P702, Pin 1 of the GEA 71. Refer also to drawing D62-2510-97-00-SB and the figure below.</p>
