MANDATORY SERVICE BULLETIN

MSB 42-087/1

MSB 42NG-016/1

Inspection of rudder control system and NLG steering bracket.

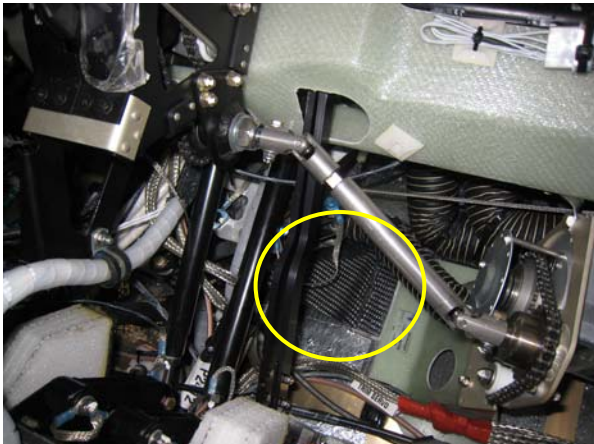
1.	Remove the pilot's seat acc. to AMM Section 25-10.
2.	Inspect the rear edges LH and RH of rudder steering bracket bond line while pushing the right rudder pedal. Look especially for cracks in the bonding paste. (see picture 1)
3.	If cracks are found in bond line, repair in accordance with Instruction III.2.
4.	<p>Check the clearance (min. 2 mm (0.08 in)) between T-yoke bolt for copilot right rudder cable and NLG steering rod and the clearance between bolt head and support plate. (see picture 1 and picture 2)</p> <div style="display: flex; justify-content: space-around;">

5.	If clearances between T-yoke bolt for copilot right rudder cable and steering rod or support plate are too small, adjust in accordance with Instruction III.3.
6.	Install the pilot's seat access panel (AMM Section 25-10).
7.	Clean working area and check for foreign objects.
8.	Perform functional check of altered, repaired and new parts.
9.	Test all systems in working area for function.
10.	Make necessary entries into aircraft logs.
