# MANDATORY SERVICE BULLETIN

## NO. MSB 42NG-018/1

#### I.5 Subject

This Service Bulletin prescribes the replacement of the possibly non conforming turbo connector assy D64-8122-20-00 by a conforming part of an improved design.

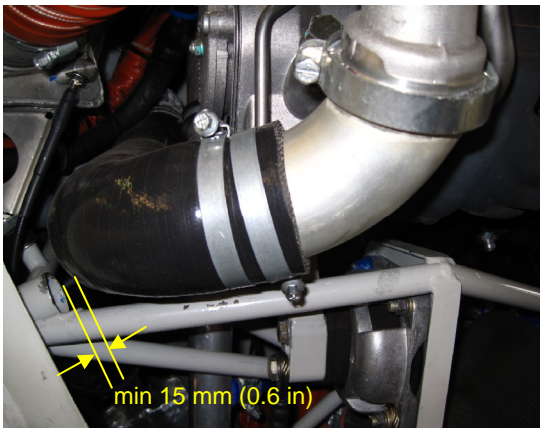
Picture 1

Note: Make sure that the minimum distances shown in pictures 1 and 2 are met.

5 Install charged air hose to the turbo connector assy (overlap length min. 45 mm / 1.8 in) with 2 hose clamps TORRO\_60-80\_12\_W1 (refer to drawing 1 and 2). The tightening torque is 5 Nm / 3.7 lb ft.
