**MANDATORY SERVICE BULLETIN**  
**MSB 42-099/1**  
**MSB 42NG-035/1**  
supersedes MSB 42-099 & MSB 42NG-035

Type: DA 42, DA 42 M, DA 42 NG, DA 42 M-NG

Inspection / replacement of spherical rod end bearing and safety washer of nose landing gear (NLG) actuator, P/N X11-0006/2 with S/N 0155 and below.

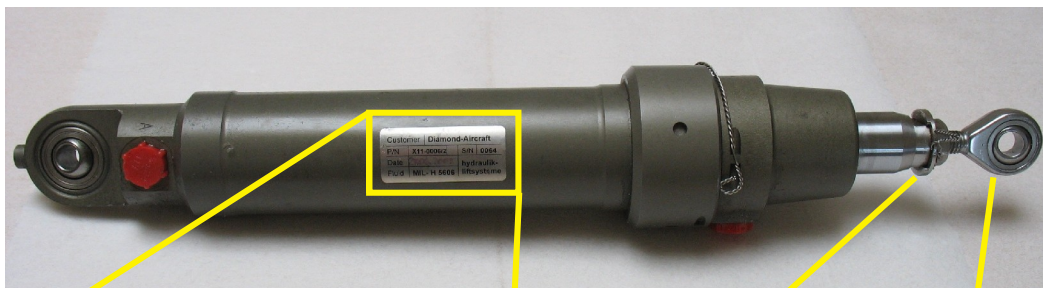
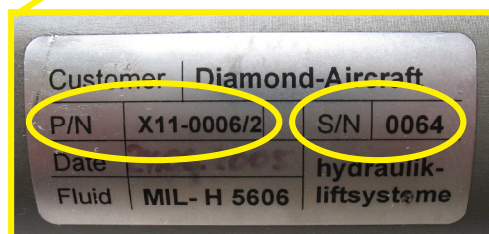
1

Identify part number (P/N) and serial number (S/N) of nose landing gear (NLG) actuator (use inspection mirror).

safety washer

rod end bearing

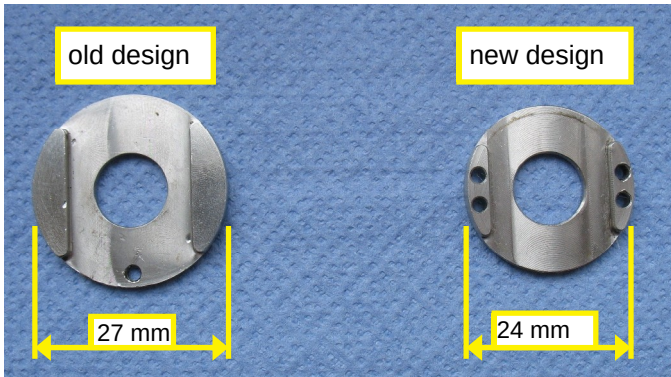
| 5 | <p>Measure diameter of safety washer.</p> <p>Possible diameters are:</p> <ul style="list-style-type: none"> <li>- 27 mm (old design, picture on the left)</li> <li>- 24 mm (P/N X11-0006-00-00.02, Rev B, new design, picture on the right).</li> </ul> |

| 6 | If diameter of safety washer is 27 mm replace it with one of the new design with 4 holes for lock wire and with reduced diameter of 24 mm, P/N X11-0006-00-00.02, Rev B. |

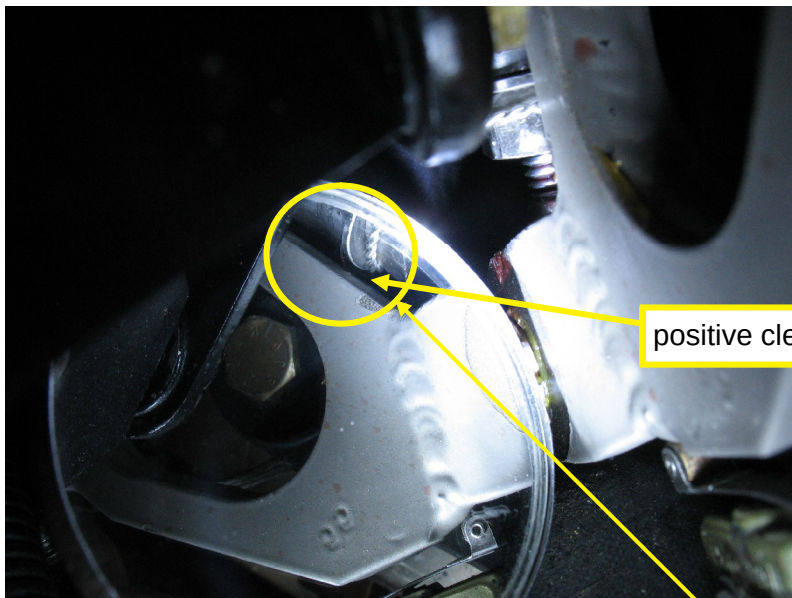
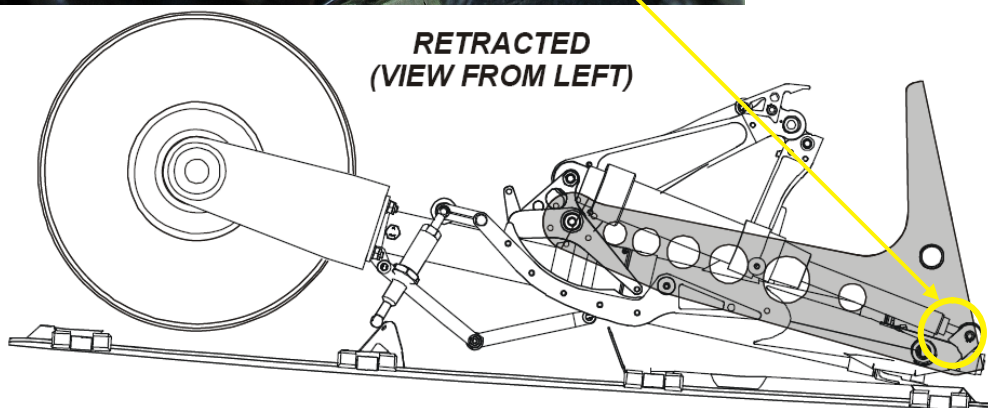
14

Carry out a landing gear extension and retraction test in accordance with AMM, section 32-30 and check for positive clearance between NLG actuator safety washer and actuator attachment lever at the NLG leg when the landing gear is retracted (use inspection mirror).

If there is no positive clearance between NLG actuator safety washer and actuator attachment lever at the NLG leg, check adjustment of NLG actuator length according to AMM, section 32-20. In case no positive clearance can be adjusted, contact Diamond Aircraft Industries GmbH.
