# OPTIONAL SERVICE BULLETIN

## OSB 42NG-064

Replacement of old coolant tank assy by new design.

## WI-OSB 42NG-064

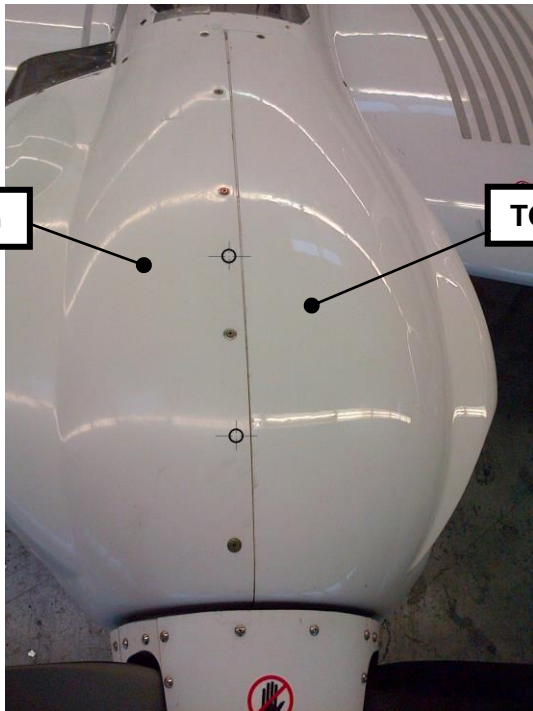
1	<p>Remove the top LH and RH cowling of the affected engine i.a.w. AMM Section 71-10.</p> <p><b>Note: If the top LH and RH cowling of the affected engine have 2 additional camlocs installed acc. to picture below, the 4. camloc from spinner backwards must be removed acc. to step 2 – step 4. If the top LH and RH cowling of the affected engine do not have 2 additional camlocs installed acc. to picture below, skip step 2 – step 4.</b></p>

2	<p>Remove the latch of the 4. camloc from spinner backwards in top LH cowling by drilling out the blind rivets.</p>
3	<p>Remove the bolt of the 4. camloc from spinner backwards in top RH cowling.</p> <p><b>Note: Leave the camloc grommet and the retainer ring in place.</b></p>

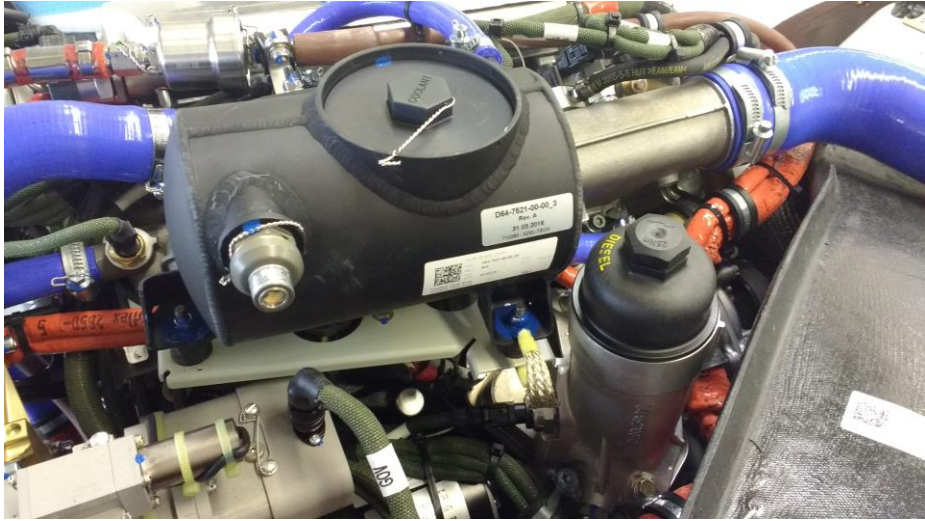
This Service Bulletin describes the replacement of the old coolant tank assy by the new coolant tank D64-7521-00-00\_03.

The redesigned coolant tank has an improved silicate cartridge mounting and an integrated mesh.

5	<p>Remove the old coolant tank i.a.w. AMM Section 75-00.</p>
6	<p>Install the new coolant tank D64-7521-00-00_03 i.a.w. AMM Section 75-00.</p>
