RECOMMENDED SERVICE BULLETIN

RSB 42-125

RSB 42NG-065

Replacement of steel pin of door handle mechanism of canopy and passenger door with an improved design.

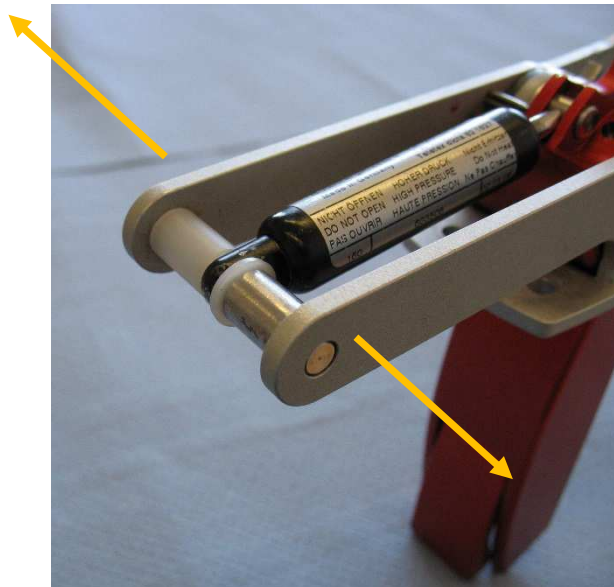
Caution: Bend the side parts of the door handle mechanism frame away from each other only as far as necessary. If the side parts are bent too much and permanently deformed, the whole door handle mechanism must be replaced.

Install the new steel pin with the polyamide washer and the polyamide distance bush to the door handle mechanism frame:

- Move the steel pin into position.
- Carefully bend the side parts of the door handle mechanism frame away from each other as shown by the yellow arrows in the picture below so that the steel pin can snap into the holes of the side parts of the door handle mechanism frame.
