MANDATORY SERVICE BULLETIN

MSB 42-126/1

MSB 42NG-066/1

Inspection of flap bell crank for cracks, installation of two spacers instead of one long spacer and replacement of early revisions of the affected flap bell crank.

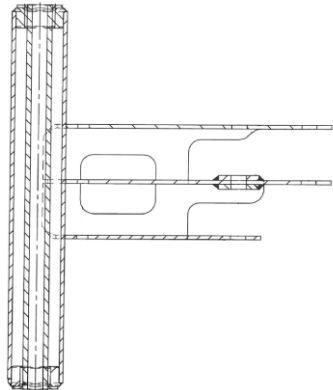
<p>D60-2757-11-00 up to Revision "d"</p> </div> <div style="text-align: center;"> <p>B)</p>

7	<p>If flap bell crank D60-2757-11-00 up to revision “d” is installed:</p> <ul style="list-style-type: none"> Replace the flap bell crank with the improved flap bell crank design D60-2757-11-00_01 in accordance with AMM, Section 27-50. <p>Note: Flap bell crank P/N D60-2757-11-00 up to Rev. “d” was installed in the following airplanes:</p> <p style="padding-left: 40px;">42.004 through 42.082, 42.107, 42.109 through 42.113, 42.AC001 through 42.AC006</p> <p>Note: If necessary, remove the aileron push rods from the aileron bell crank and remove the aileron bell crank to gain better access for removing the flap bell crank. Re-install aileron bell crank and aileron push rods after replacement of flap bell crank.</p>
8	<p>Install the 4 flap pushrods to the flap bell crank.</p>
9	<p>Install the flap actuator to the flap bell crank in accordance with AMM, section 27-50:</p> <ul style="list-style-type: none"> Position the flap actuator rod end bearing between the two spacers DS BU2-10-06-0065-C, which are installed as a replacement for the long single spacer, as shown in the picture below.

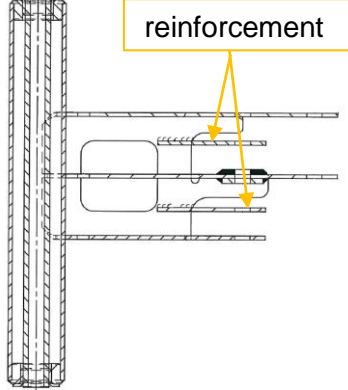
<p>D60-2757-11-00 Revisions "e" and "f"</p> </div> <div style="text-align: center;"> <p>C)</p>

- Examine the flap bell crank for cracks and deformation in the area where the flap pushrods are attached to the flap bell crank as shown in the figure below.
- If cracks or deformation are found, replace the flap bell crank with the improved flap bell crank D60-2757-11-00_01 in accordance with AMM, Section 27-50.

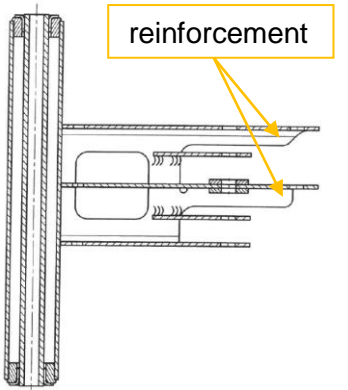
<p>D60-2757-11-00_01</p> </div> </div>
