MANDATORY SERVICE BULLETIN

MSB 42-137/1

MSB 42NG-079/1

Inspection of rudder T-yoke axle nut for looseness.

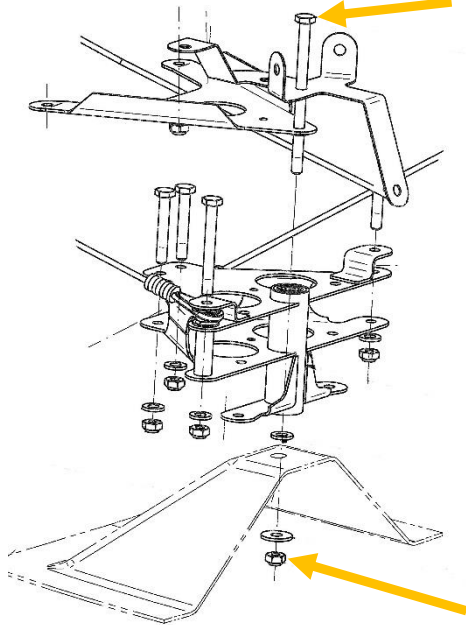
1	Remove the pilot and copilot seat in accordance with AMM Section 25-10.
2	Remove the middle tunnel front cover in accordance with AMM Section 25-10.
3	<p>Check the self-locking nut for correct torque:</p> <ul style="list-style-type: none"> • Block the self-locking nut with a ring-wrench. • Apply a torque of approx. 6 Nm to the head of the T-yoke axle.

4	<p>If the T-yoke axle can be rotated more than one half turn or if the nut is loose:</p> <ul style="list-style-type: none"> • do a condition inspection in accordance with AMM and MSB 42-087 / MSB 42NG-016, • correct any deficiencies, • replace the self-locking nut with a new self-locking nut.
5	Install the middle tunnel front cover in accordance with AMM Section 25-10.
6	Install the pilot and copilot seat in accordance with AMM Section 25-10.
7	Clean working area and check for foreign objects.
8	Perform functional check of altered, repaired and new parts.
