RECOMMENDED SERVICE BULLETIN

RSB 42-139

RSB 42NG-081

Replacement of rudder T-yoke axle with improved design.

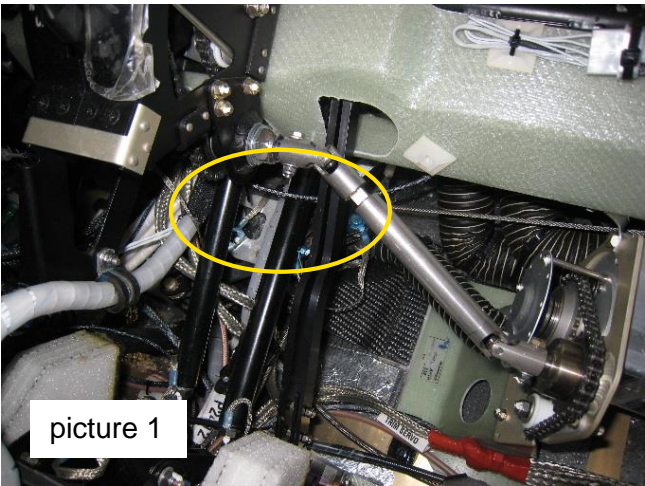
<p>picture 1</p>

Pictures 1 – 4 show the affected area.

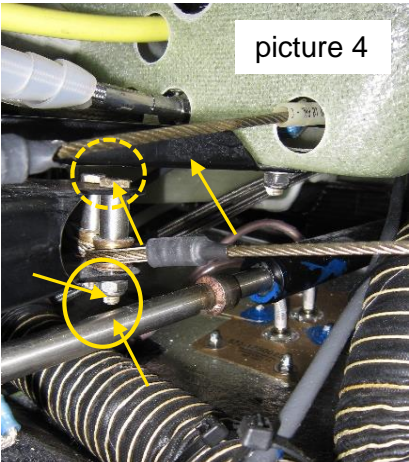
<p>picture 4</p>

- between end of T-yoke bolts for copilot's right rudder cable & pilot's left rudder cable and nose landing gear (NLG) steering rod (continuous circle in picture 4)
- and between head of T-yoke bolts for copilot's right rudder cable & pilot's left rudder cable and support plate (dashed circle in picture 4).

Record the measured clearances. Each clearance must be greater than 2 mm (0.08 in).

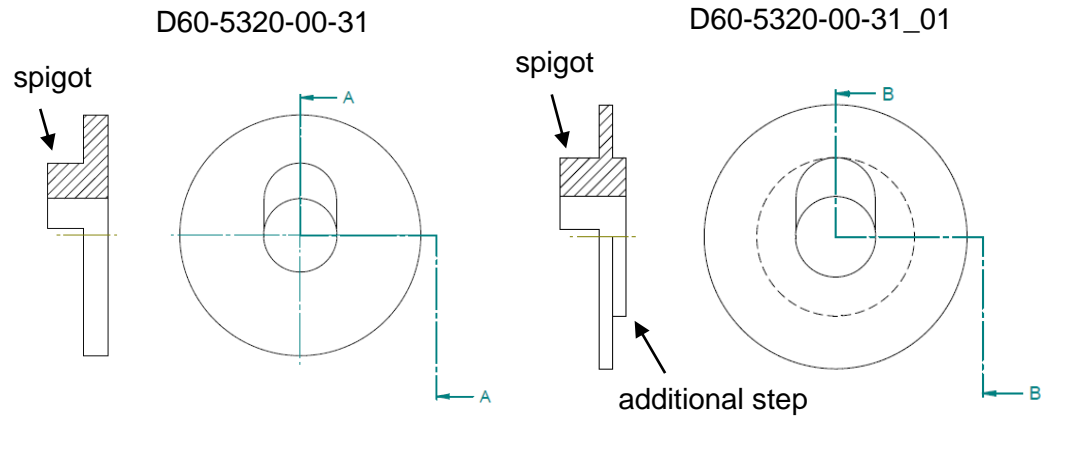
11.	<p>Verify, if an oblong hole washer was installed to the rudder steering bracket in accordance with MSB 42-087 / MSB 42NG-016. There are 3 different installation variants, which can be found in airplanes in field.</p> <p>Variant 1: No oblong hole washer is installed to the rudder steering bracket. Instead, a standard washer (13 mm outer diameter) is installed between T-yoke and rudder steering bracket.</p> <p>Variant 2: Oblong hole washer D60-5320-00-31 (outer diameter 20 mm) was bonded to the rudder steering bracket, in accordance with MSB 42-087 / MSB 42NG-016.</p> <p>Variant 3: Oblong hole washer D60-5320-00-31_01 (outer diameter 20 mm) was bonded to the rudder steering bracket, in accordance with MSB 42-087 / MSB 42NG-016.</p> <p>Note: The two different designs of oblong hole washers D60-5320-00-31 and D60-5320-00-31_01 can be identified in figure 1.</p> <div style="text-align: center;">

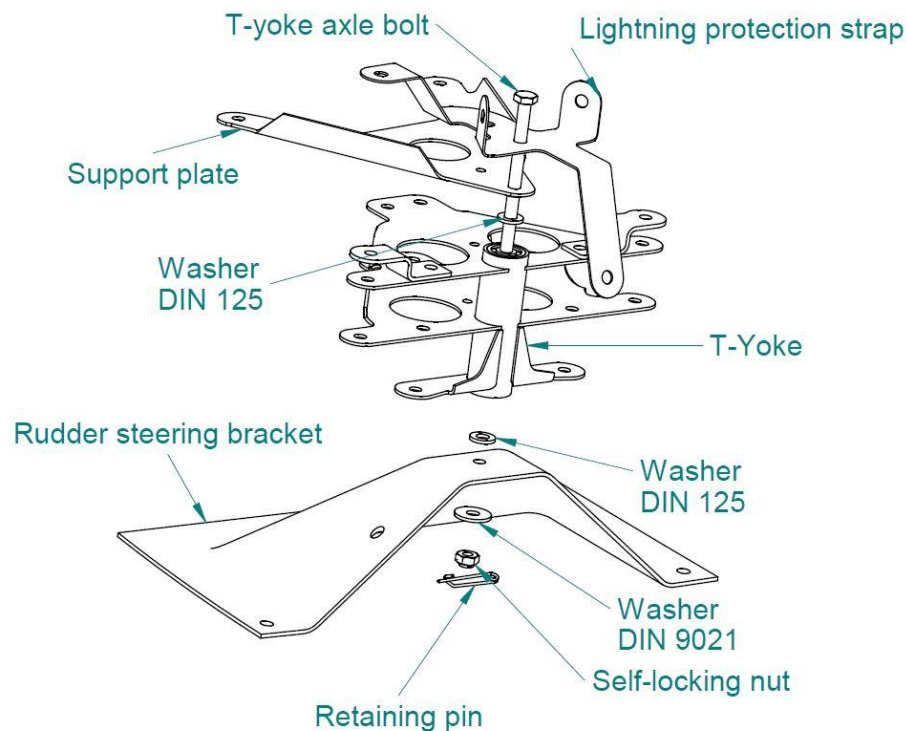
figure 2

Note: The retaining pin can damage the heating hose if not installed perpendicular to the flight direction.

- the new T-yoke bolt D60-5320-00-32,
- a DIN 125 washer between support plate and T-yoke,
- a DIN 125 washer between the T-yoke and the rudder steering bracket,
- a DIN 9021 washer between the self-locking nut and the rudder steering bracket,
- a new self-locking nut and
- a retaining pin AN416-1 perpendicular to the flight direction

Tighten the T-yoke bolt with a tightening torque of 10 Nm.

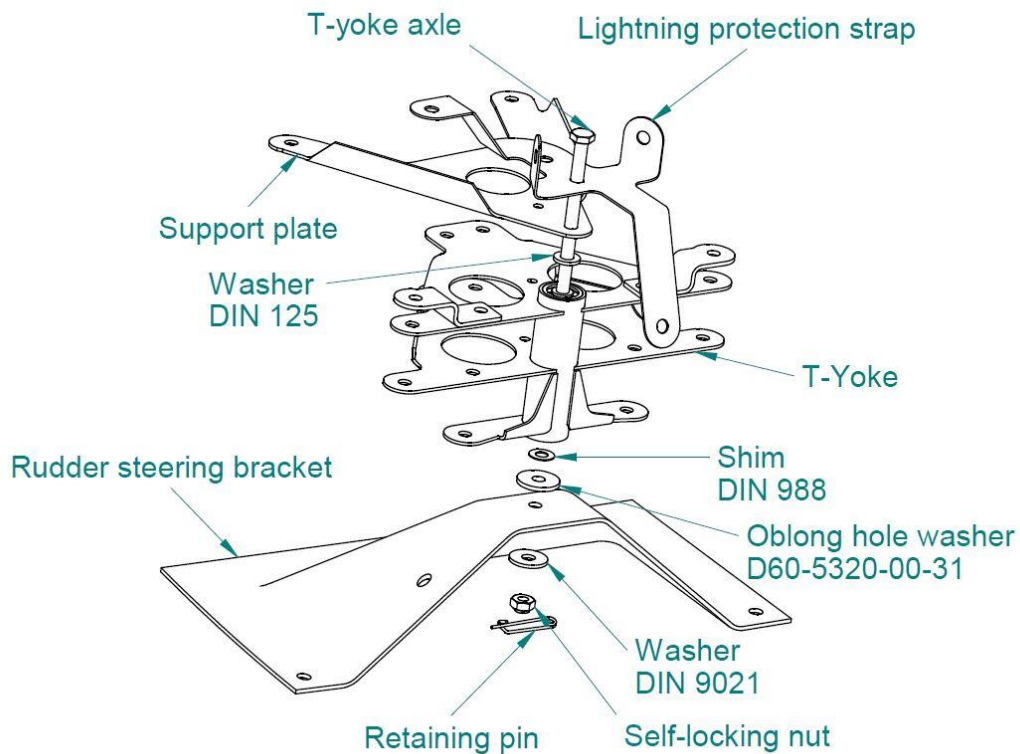
figure 3

Note: The retaining pin can damage the heating hose if not installed perpendicular to the flight direction.

- the new T-yoke bolt D60-5320-00-32,
- a DIN 125 washer between support plate and T-yoke,
- a DIN 988 shim between the T-yoke and well bonded oblong hole washer,
- a DIN 9021 washer between the self-locking nut and the rudder steering bracket,
- a new self-locking nut and
- a retaining pin AN416-1 perpendicular to the flight direction
