MANDATORY SERVICE BULLETIN

MSB 42NG-082

Cut-out in rudder gap cover.

ATA-Code: 55-40

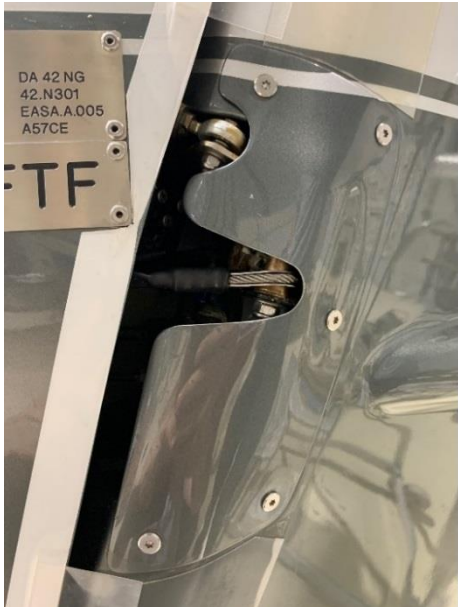
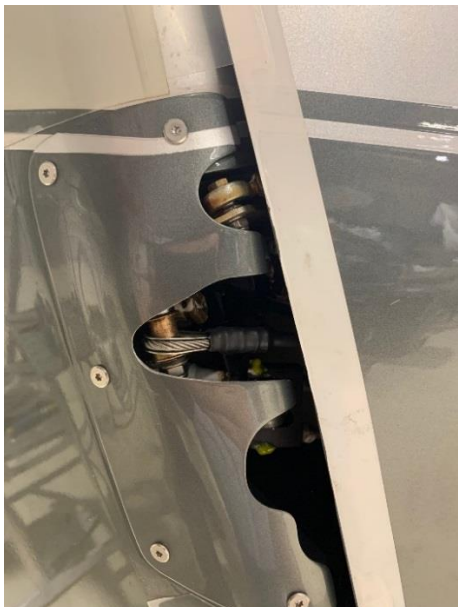
Diamond Aircraft Industries have received reports of chafing marks on the rudder control cables on some airplanes. The chafing marks could be traced back to insufficient clearance between the rudder gap covers and the rudder control cables in the area where the rudder control cable thimbles are connected to the rudder mounting bracket.

1	Remove both rudder gap covers from the rudder.
2	Examine the rudder control cables in accordance with FAA AC 43.13-1B, paragraph 7-149. Replace rudder control cables, if necessary.
3	<p>Use the template in Appendix A for enlarging the cut-out of the left hand (LH) rudder gap cover in the area marked by the circle.</p> <ul style="list-style-type: none"> • Extend the cut-out up to the line that is marked by the distance a. • Trial-install the LH rudder gap cover to the rudder. • Move the rudder to full deflection in both directions and check the clearance between the LH rudder control cable / rudder control cable thimble and the LH rudder gap cover. • Make sure, there is a minimum clearance of 2 mm in any rudder position. If necessary, extend the cut-out of the LH rudder gap cover in the area where the clearance is less than 2 mm.
4	<p>Use the template in Appendix B for enlarging the cut-out of the right hand (RH) rudder gap cover in the area marked by the circle.</p> <ul style="list-style-type: none"> • Extend the cut-out up to the line that is marked by the distance b. • Trial-install the rudder gap cover to the rudder. • Move the rudder to full deflection in both directions and check the clearance between the RH rudder control cable / rudder control cable thimble and the RH rudder gap cover. • Make sure, there is a minimum clearance of 2 mm in any rudder position. If necessary, extend the cut-out of the RH rudder gap cover in the area where the clearance is less than 2 mm.

5	<p>Install both rudder gap covers to the rudder.</p> <div style="display: flex; justify-content: space-around;">
