MANDATORY SERVICE BULLETIN

MSB 42-143/1

MSB 42NG-086/1

Inspection of hole position and condition in the rudder steering bracket.

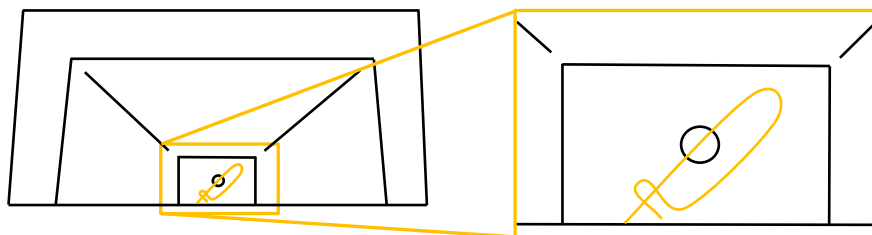
Note: The Fokker Needle can damage the heating hose if the pointy end is not hidden under the rudder steering bracket.

- Block the self-locking nut with an open-end wrench.
- Turn the T-yoke bolt, until the self-locking nut is positioned above the hole for the additional Fokker Needle. Do not yet tighten the T-yoke bolt.
- Remove the open-end wrench.
- Turn the T-yoke bolt to a position, so that the Fokker Needle can be installed to the T-yoke bolt.
- Install Fokker Needle.
- Turn the T-yoke bolt by 180°.
- Close the Fokker Needle.
- Block the self-locking nut with an open-end wrench.
- Torque the T-yoke bolt with 6 Nm.
- Remove the open-end wrench.
- Turn the T-yoke bolt without blocking the self-locking nut to a position, so that the pointy end of the Fokker Needle is directly below the edge of the rudder steering bracket (refer to sketch).

- Block the self-locking nut with an open-end wrench.
- Torque the T-yoke bolt with 9 Nm.
- Make sure the pointy end of the Fokker Needle is hidden under the rudder steering bracket and does not damage the heating hose.

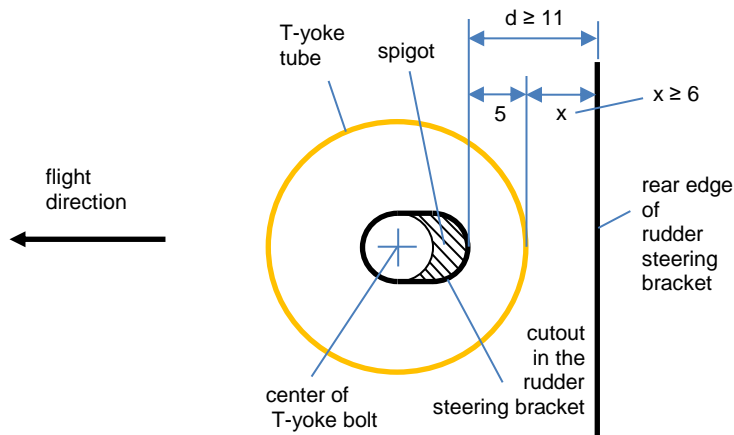
8. If an oblong hole washer is installed to the rudder steering bracket with the spigot facing backwards, distance **d** is less than 11 mm. Return to section III.
