MANDATORY SERVICE BULLETIN

MSB 42-143/1

MSB 42NG-086/1

Inspection of hole position and condition in the rudder steering bracket.

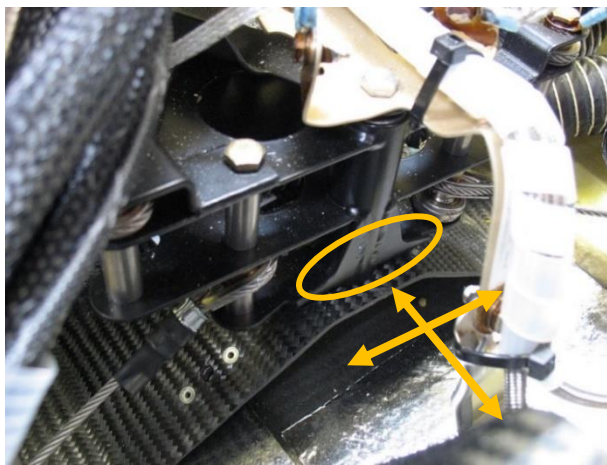
11. Examine the hole in the rudder steering bracket for wear and play. Look especially for possible lateral movement of the lower part of the T-yoke:

12. If a worn or enlarged hole, or play of the T-yoke bolt in the hole of the rudder steering bracket has been found,

- disconnect the NLG steering rod from the T-yoke,
- disconnect all rudder control cables,
- remove the T-yoke bolt,
- remove the T-yoke,
- make sure that all washers are removed from the airplane,
- send all information to support-austria@diamondaircraft.com, containing:
 - dimensions of the worn / enlarged hole in the rudder steering bracket
 - detailed photographs of the worn / enlarged hole together with a measuring tape, positioned beside the hole,
 - filled-in [damage report](#), which can be downloaded from DAI technical publications home page
- request instructions for repair of the hole in the rudder steering bracket,
- proceed with step 13 after repair.

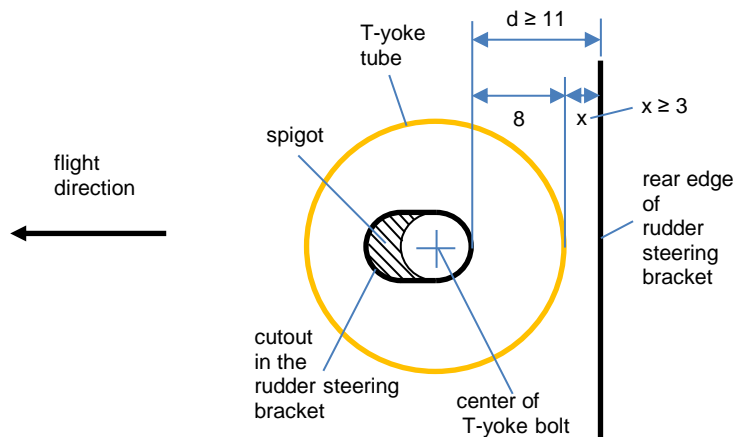
7. If an oblong hole washer is installed to the rudder steering bracket with the spigot facing in flight direction, distance **d** is at least 11 mm. Return to section III.

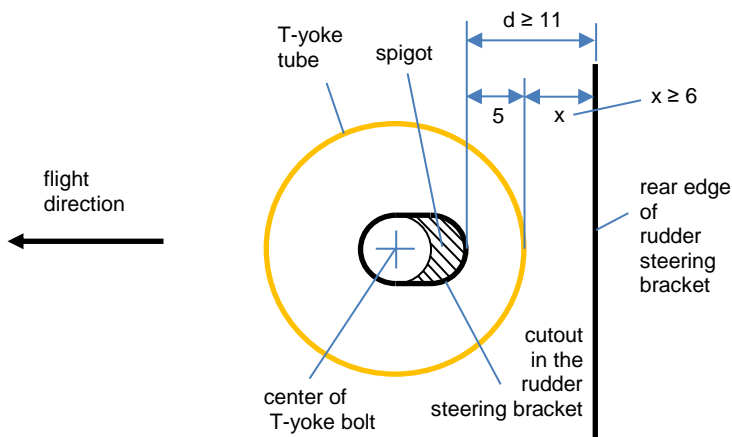
8. If an oblong hole washer is installed to the rudder steering bracket with the spigot facing backwards, distance **d** is less than 11 mm. Return to section III.
