MANDATORY SERVICE BULLETIN

MSB 42-148

MSB 42NG-094

Replacement of the main landing gear (MLG) and nose landing gear (NLG) retaining rings.

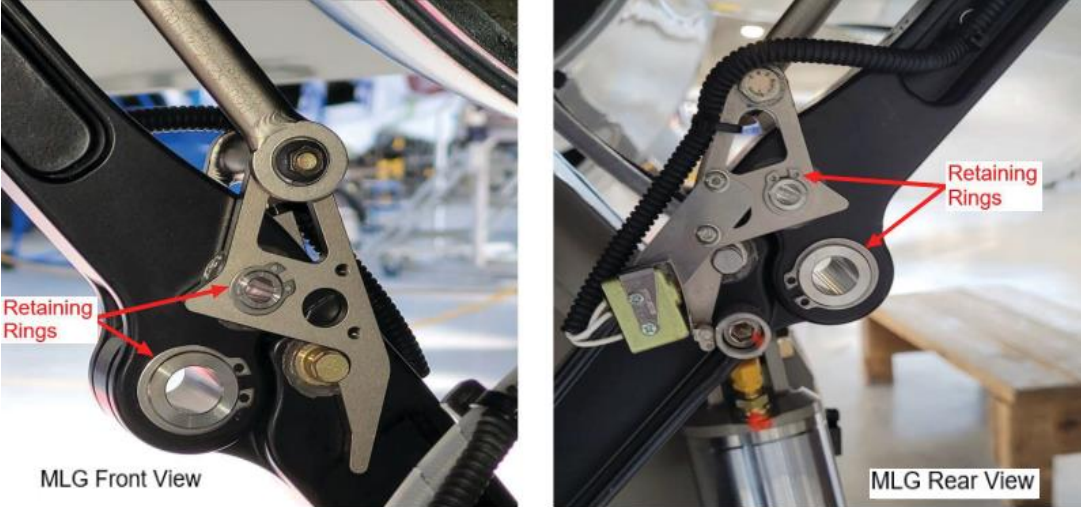
<p style="text-align: center;">Figure 1: MLG Retaining Rings</p>

It was discovered that the main and nose landing gear braces of some aircraft had retaining rings with insufficient level of corrosion resistance being installed. This may cause the retaining rings to corrode, sustain damage, or fail (crack). If not corrected, this may lead to failure of the landing gear. This Service Bulletin describes the replacement of those retaining rings.

3	Replace one retaining ring at a time.
4	Remove the retaining rings from the MLG legs and NLG leg as per the figures. (Refer to Figures 1 and 2 for location)
5	<p>CAUTION: Do not remove or move shafts while replacing retaining rings:</p> <p>Clean the grooves of the bearing shafts. Inspect the folding stay and bearing shafts for general condition before installing the new retaining rings.</p> <p>NOTE: If for any reason the folding stay, and/or the bearing shaft needs to be removed for repair / replacement / further inspection, perform work in accordance with AMM section 32-00, then proceed to step 6.</p>
6	<p>NOTE: Do not overstretch the retaining rings during installation. Open the rings only enough to fit over the shaft when installing.</p> <p>Install the new retaining rings. Make sure the retaining rings properly engage into the grooves of the bearing shafts.</p>
7	Clean working areas, check for foreign objects.
