# MANDATORY SERVICE BULLETIN

## MSB 42-148/1

## MSB 42NG-094/1

Replacement of the main landing gear (MLG) and nose landing gear (NLG) retaining rings.

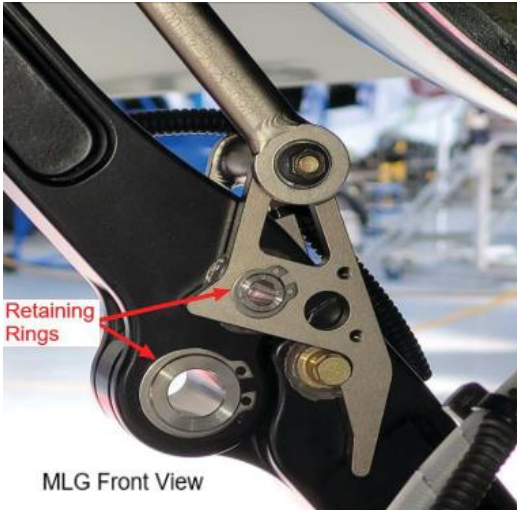
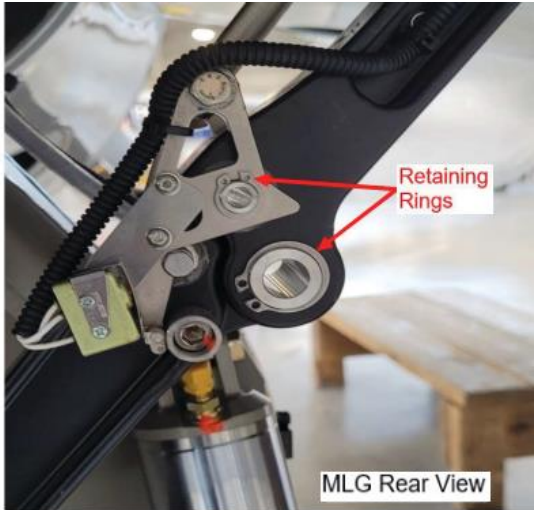
It was discovered that the main and nose landing gear braces of some aircraft had retaining rings with insufficient level of corrosion resistance being installed. This may cause the retaining rings to corrode, sustain damage, or fail (crack). If not corrected, this may lead to failure of the landing gear. This Service Bulletin describes the replacement of those retaining rings.

| 2 | <p>Locate the retaining rings. See Figure 1 for MLG locations and Figure 2 for NLG locations.</p> <div style="display: flex; justify-content: space-around; align-items: center;"> </div> <p style="text-align: center;">Figure 1: MLG Retaining Rings</p> |

| 4 | Remove the retaining rings from the MLG legs and NLG leg as per the figures. (Refer to Figures 1 and 2 for location) |
| 6 | <p><b>NOTE:</b> Do not overstretch the retaining rings during installation. Open the rings only enough to fit over the shaft when installing.</p> <p>Install the new retaining rings. Make sure the retaining rings properly engage into the grooves of the bearing shafts.</p> |
