MANDATORY SERVICE BULLETIN

MSB 42-149

MSB 42NG-095

Actions to prevent Passenger Door Separation: Installation of Placards, AFM Procedure update and Inspection/Data Gathering.

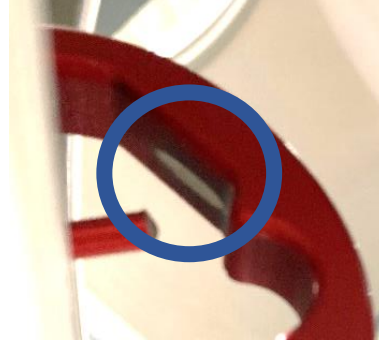
- 6 Examine the Safety Hook for signs of wear, corrosion and poor condition:
- Record the finding on the execution report in Appendix B.
 - There must be no deformation or cracks.
 - Pay particular attention to the contact area of the Actuation Pin.
 - Grooves in the Safety Hook must be less than 2 mm deep.

Replace Safety Hook, if

- any of the Safety Hook dimensions measured in this step are not within the given tolerances, or
- corrosion is found, or
- deformation, grooves, ridges or steps.

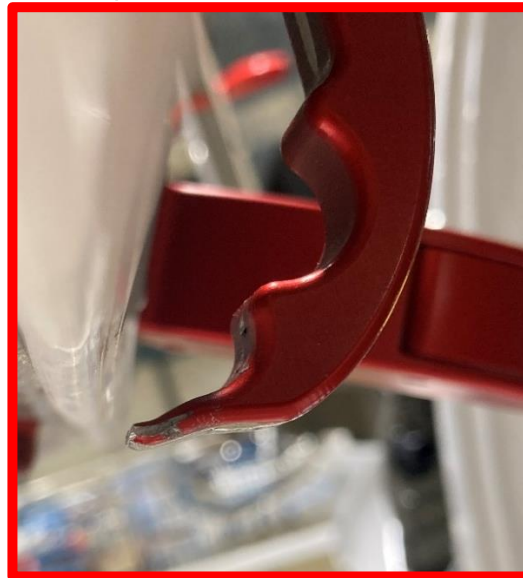
- Pay particular attention to the hook end of the Safety Hook.
 - The hook end must not be bent.
 - Not acceptable:

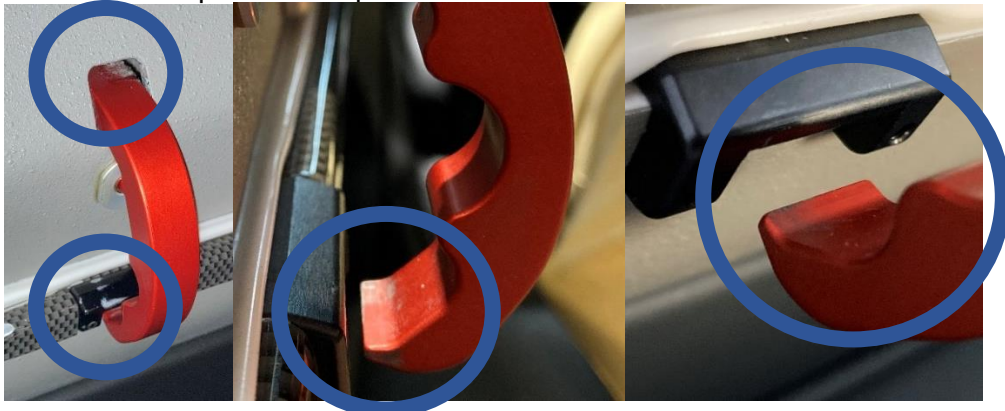
- There must be no corrosion on the contact area to the Retaining Bracket.
- Examples of acceptable conditions:

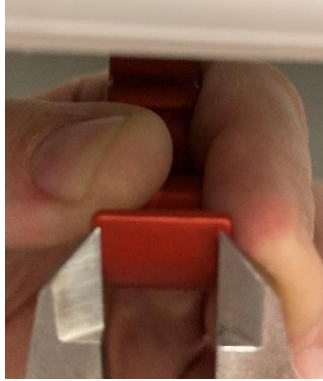
- Examine the tip of the Safety Hook for wear:
 - Wear of edges of Safety Hook:
 - The width of the tip of the Safety Hook must be greater than 10.5 mm.

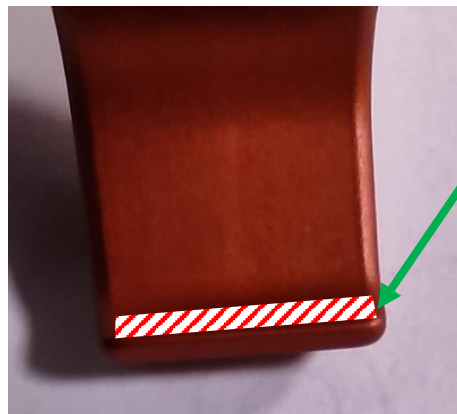
- The engaging surface of the Safety Hook is the flat surface at the tip of the Safety Hook.
 - It must be free from steps and ridges.
 - Scratches or uniform wear of surface protection are permitted.

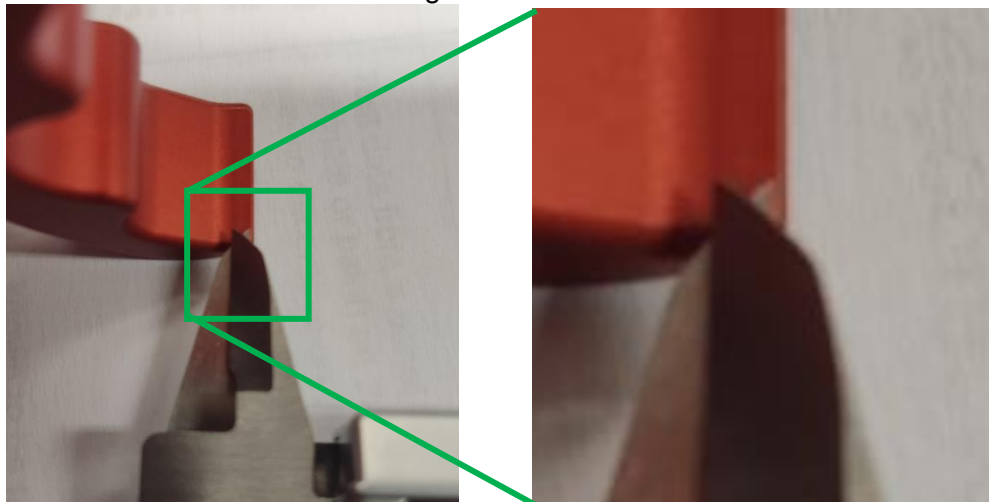
- Measure the width of the engaging surface.
 - The width must be greater than 1.5 mm.

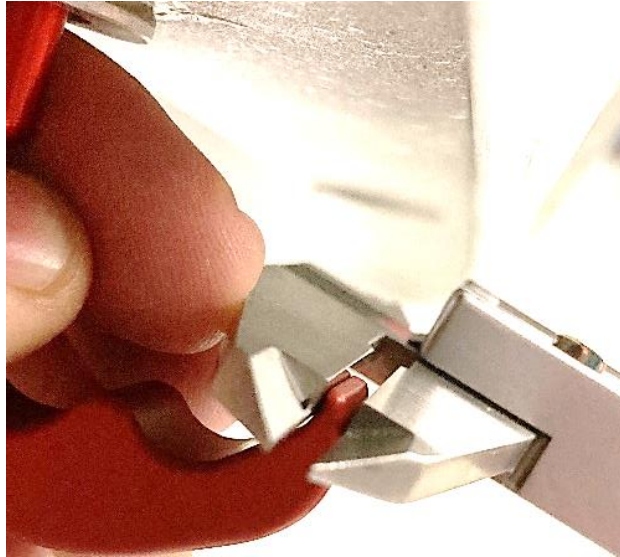
- Measure the maximum thickness of the Safety Hook at the location of the engaging surface, perpendicular to the engaging surface.
 - The thickness must be greater than 2.5 mm.
 - The maximum variation of measured thickness over the width of the Safety Hook must be less than 0.2 mm.

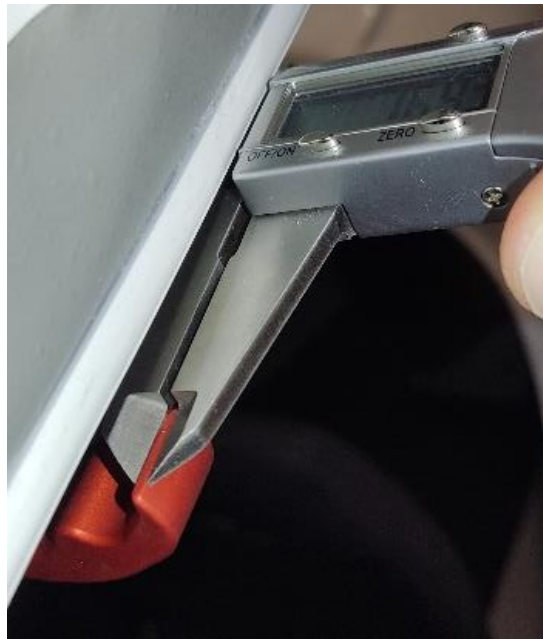
- Measure the minimum thickness of the Safety Hook at the location of the engaging surface, perpendicular to the engaging surface.
 - The minimum thickness must be greater than 1.5 mm.
 - The maximum variation of this value over the whole width must be less than 0.2 mm.

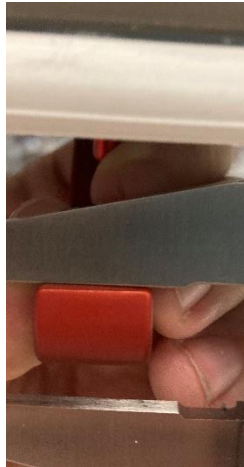
- The edge of the engaging section of the Safety Hook that is facing towards the Retaining Bracket must be free from ridges.

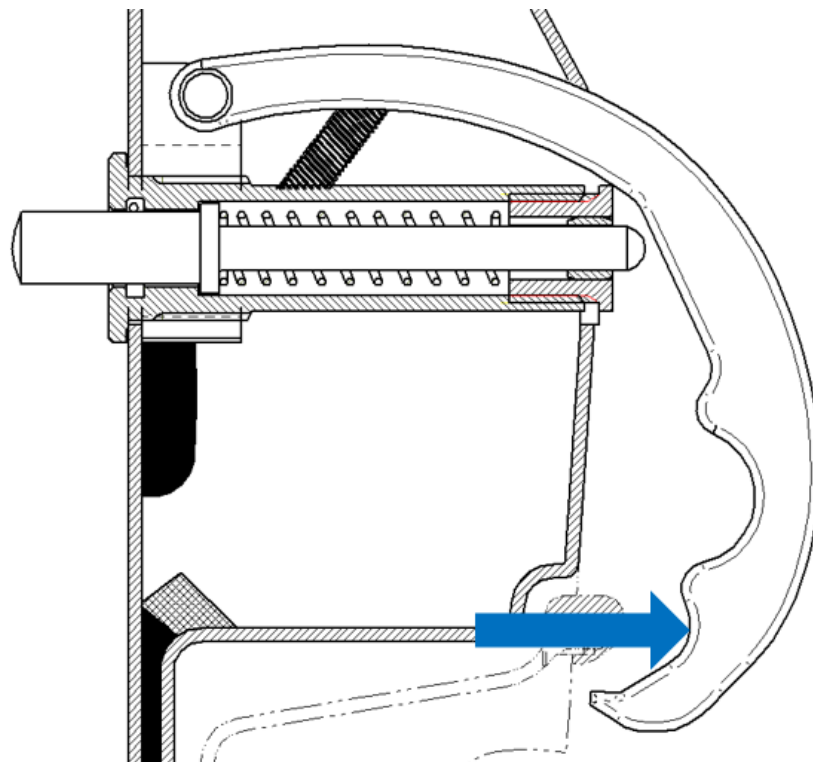
- 7 Measure the force to lift the Safety Hook from its resting position. Typically, the Safety Hook is resting on the cut-out in the Passenger Door.
- Open the Passenger Door.

- Attach a spring scale with a suitable measurement range to the lowest grip. Refer to the figure below.
 - Measure the force to lift the Safety Hook from its resting position.

- Verify that the Safety Hook does not lift from its resting position when a force of 0.1 kg / 1 N is applied.
 - If the Safety Hook lifts with a smaller force, check the spring for correct function. Replace if necessary and repeat the test.

- If the Safety Hook does not snap back:
 - Examine the spring of the Safety Hook.
 - Check the attachment of the Safety Hook for increased friction.
 - Check for interferences in the range of motion of the Safety Hook

- Record findings on the execution report in Appendix B.
 - Rectify any findings.
 - Repeat the test.
 - In case of doubt, contact Diamond Aircraft Industries GmbH

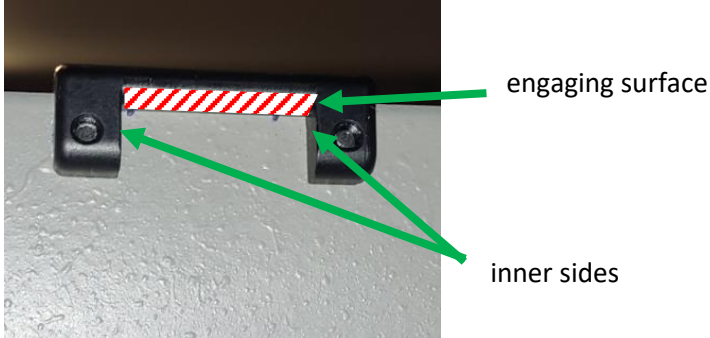
9	<p>If Retaining Bracket DA4-5200-00-69 is installed (refer to step 8.):</p> <ul style="list-style-type: none"> • Replace the Retaining Bracket according to MSB 42-083/MSB 42NG-014 (refer also to EASA AD 2010-0235). • Record replacement of the retaining bracket on the execution report in Appendix B.
10	<p>Examine the Retaining Bracket for signs of wear, corrosion and poor condition.</p> <ul style="list-style-type: none"> • There must be no corrosion on the Retaining Bracket. • Wear at the inner sides of the Retaining Bracket: maximum 0.5 mm per side. • The engaging surface of the Retaining Bracket and the edge of the engaging surface facing the Retaining Bracket must be free from steps and ridges. • Scratches or uniform wear of surface protection are permitted.

Replace the Retaining Bracket, if:

- any of the Retaining Bracket dimensions are not within the given tolerances, or
- if corrosion is found, or
- the wear limit is exceeded, or
- steps or ridges are found.

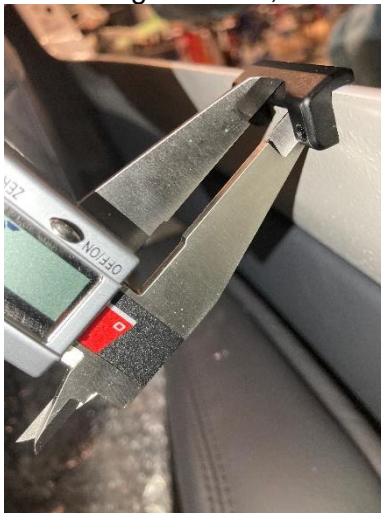
<ul style="list-style-type: none"> • The thickness of the Retaining Bracket measured perpendicular to the upper surface must be greater than <ul style="list-style-type: none"> ○ 4 mm (for Retaining Bracket DA4-5200-00-69_02 (extended with undercut), or ○ 6 mm (for all other Retaining Brackets, refer to Step 8).

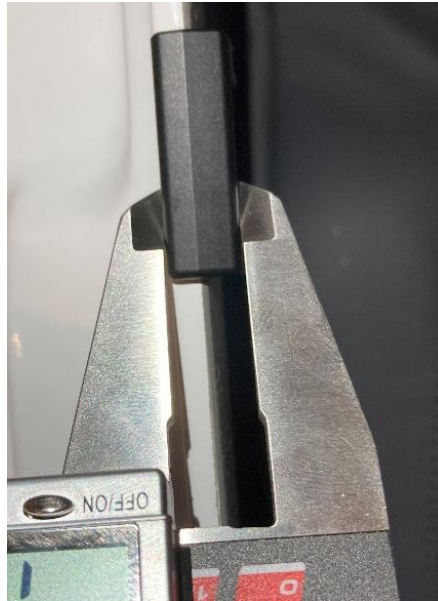
<ul style="list-style-type: none"> • The width of the Retaining Bracket (measured i.a.w. picture below) must be greater than 10 mm. <ul style="list-style-type: none"> ○ Variation of the width over the whole length of the Retaining Bracket must be less than 0.2 mm.

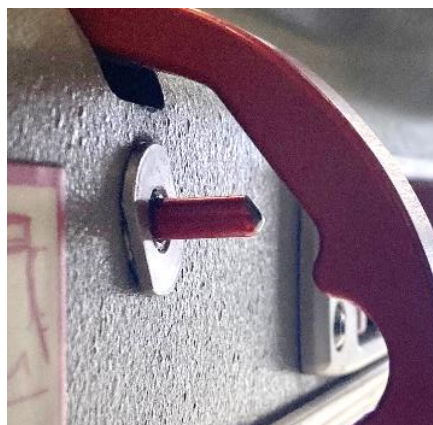
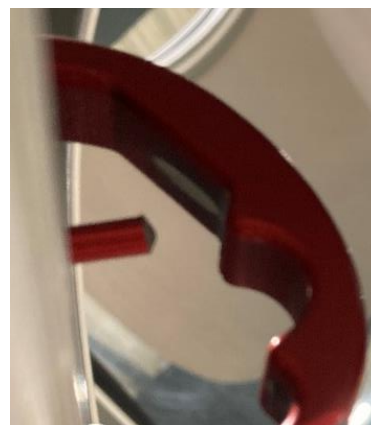
- 13 Examine the Safety Hook Actuation Pin for corrosion, wear and poor condition.
- There must be no corrosion on the sliding surfaces.
 - If corrosion is found, replace corroded parts.
 - The play of the Actuation Pin in the bushing must be less than 1 mm.
 - If the play is greater than 1 mm, replace the affected parts.
 - Record any findings and replaced parts on the execution report in Appendix B.

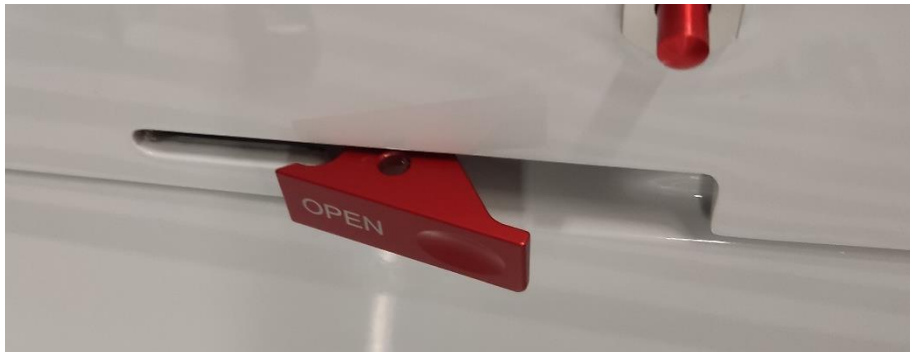
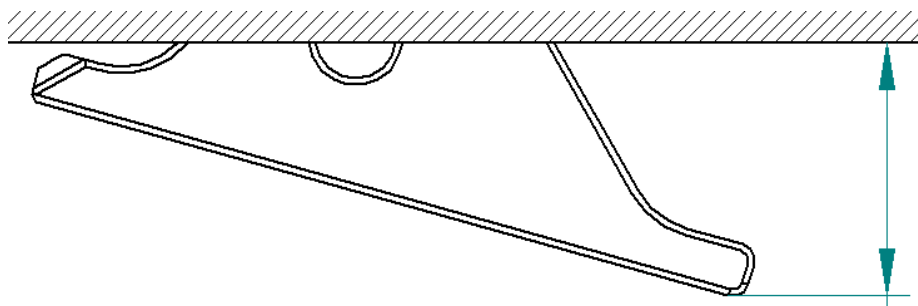
18 If MÄM 42-097 is installed (refer to step 15), examine the condition of the gas spring of the latching mechanism:

- Open the Passenger Door.
- Move the Passenger Door handle into unlatched position.
- Slowly move the Passenger Door handle towards the latched position and measure the distance at which the Passenger Door handle snaps into latched position by itself (measured at the outermost point of the lever, refer to sketch below).

- If the distance is less than 20 mm, replace the compression gas spring. Refer to AMM Section 52-10. Repeat this step after replacement.
 - If the distance is less than 20 mm after replacement of the gas spring, the cause is high friction in the latching system.
 - Examine the latching bolts according to step 22.
 - If the reason for high friction in the latching system cannot be found, replace the latching system i.a.w. AMM section 52-10.
 - Repeat this step after parts replacement.
- Record the measured distance and any replacements on the execution report in Appendix B.

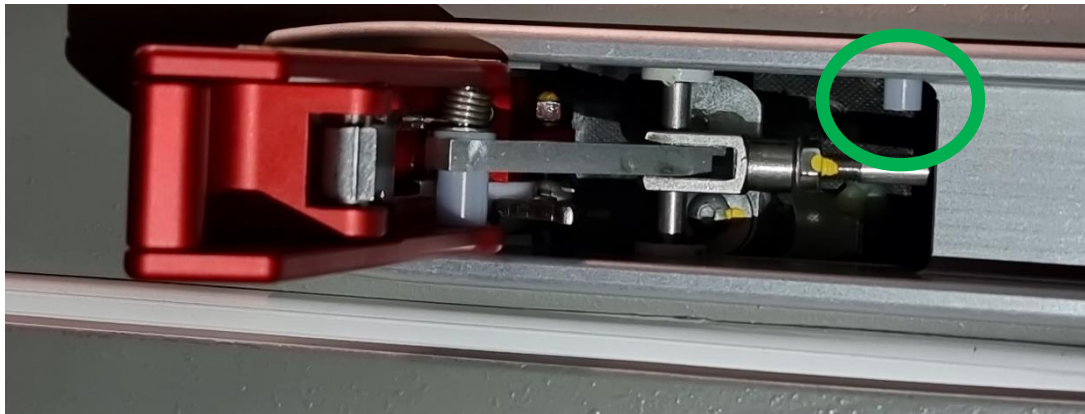
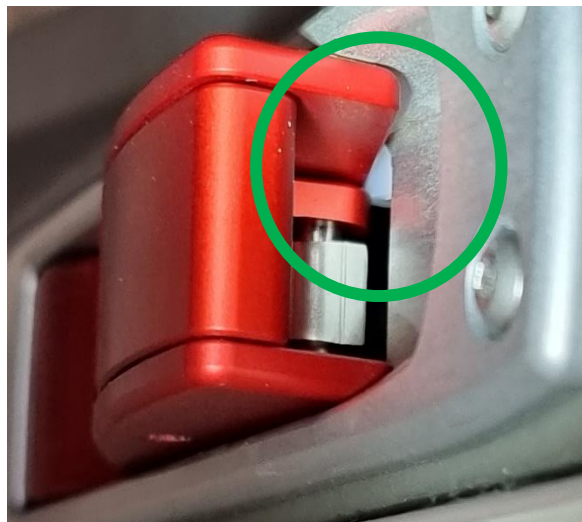
19 If MÄM 42-097 is installed (refer to step 15), examine the adjustment of the gas spring in the Passenger Door latching mechanism.

The gas spring inside the door handle must push the door handle into the latched position firmly against the stop:

- Open the Passenger Door.
- Move the Passenger Door Handle to the latched position.
- Examine, if the door handle is pushed into the mechanical stop inside the door handle mechanism (marked in the pictures below).
- If the Passenger Door Handle is not pushed against the mechanical stop by the gas spring, adjust the gas spring (refer to AMM section 52-10) and repeat this step.
- Record whether the gas spring was adjusted properly on the execution report in Appendix B.

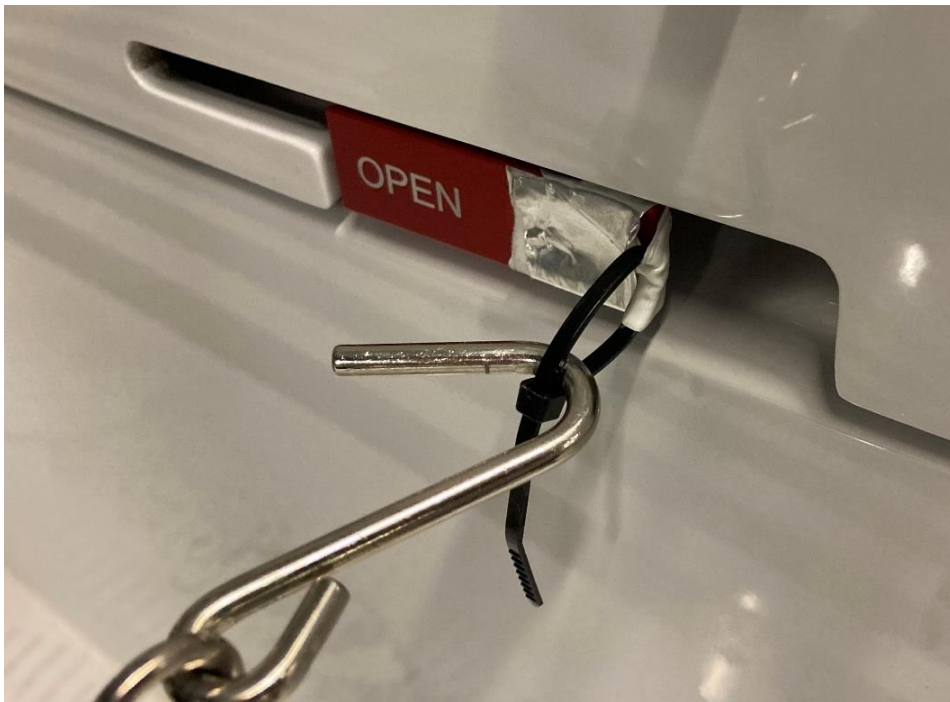
Example force measurement

21 Measure the Passenger Door handle actuation force:

- Measure the force necessary to move the Passenger Door handle to the unlatched position.
 - The force must exceed 1.8 kg / 18 N.
 - If the force does not exceed 1.8 kg / 18 N
 - Identify the reason for not reaching the minimum force limit and rectify any findings.
 - Repeat the test.
- Record the measured forces and any findings on the execution report in Appendix B.

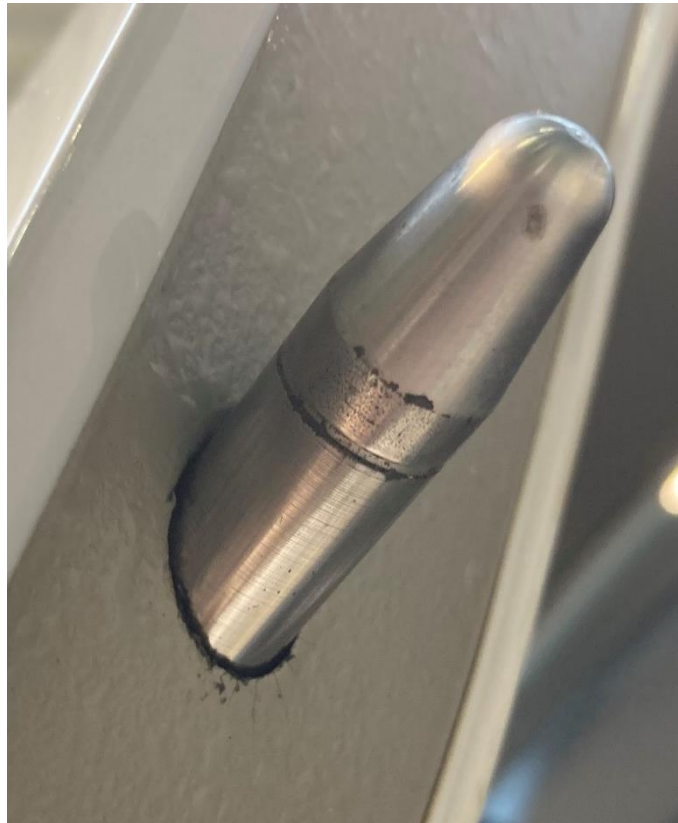
Example of a serviceable Latching Bolt

22 Examine the latching bolts of the Passenger Door for looseness, excessive play, wear, corrosion, and poor condition.

- It must not be possible to rotate the latching bolts by hand force.
- The radial play of the latching bolts must not exceed 0.8 mm at the tip of the latching bolts.
 - If the radial play exceeds 0.8 mm, contact Diamond Aircraft Industries GmbH.
- No sign of corrosion is allowed.
 - If signs of corrosions on the latching bolts are found, replace the latching bolts.
- No deformation (dents, bends, cracks) on the latching bolts is allowed.
 - If deformations of the latching bolts are found, replace the latching bolts.
- If parts are replaced, repeat this step.
- In case of doubt, contact DAI for instructions.
- Record any findings on the execution report in Appendix B.

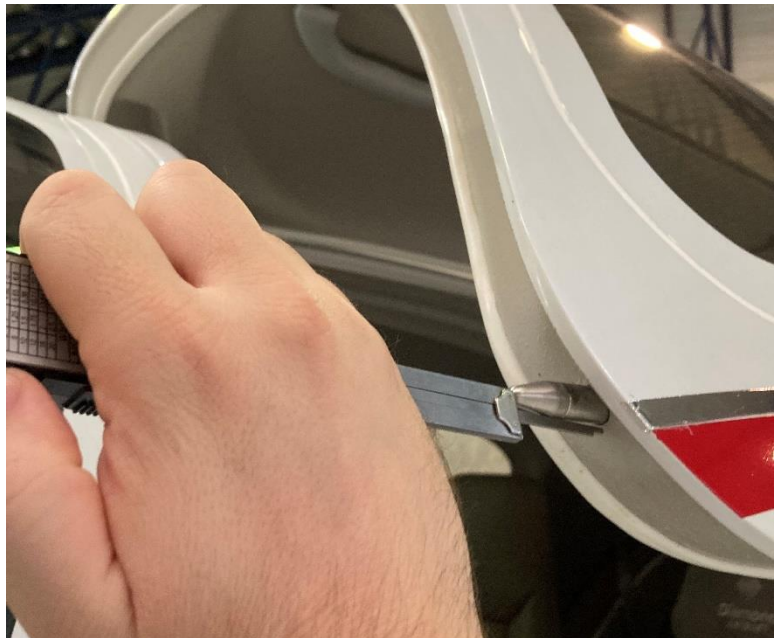
Front Latching Bolt

- Measure the extension length at the bottom of the front and rear latching bolts in mm. Refer to pictures below.
 - The front latching bolt extension length must be 40 ± 2 mm.

- If the extension length is out of tolerance, adjust the latching bolt if possible, or replace latching bolt if necessary.
 - After adjustment or replacement repeat this step.

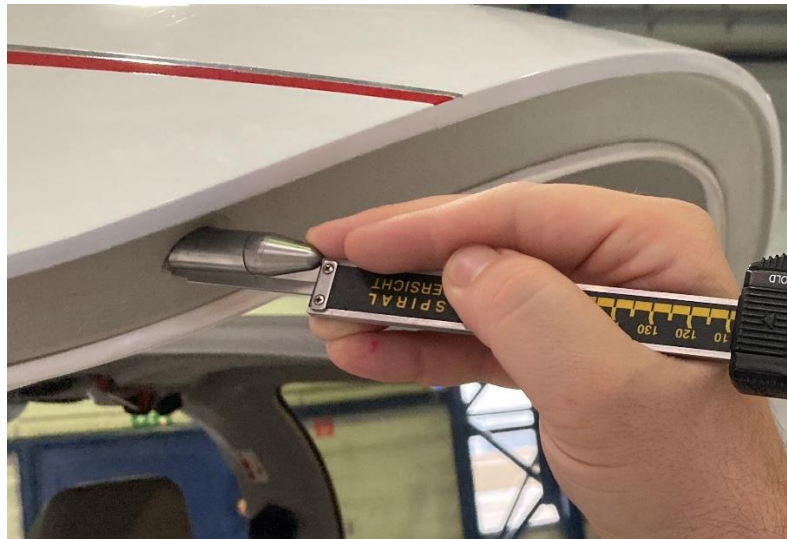
Rear Latching Bolt

- If MÄM 42-687 is **not** installed, the rear latching bolt extension length must be 40 ± 2 mm.
 - If the extension length is out of tolerance, adjust the latching bolt if possible, or replace latching bolt if necessary.

- After adjustment or replacement repeat this step.
 - If MÄM 42-687 is installed, the rear latching bolt extension length must be 44 ± 1 mm.
 - If the extension length is out of tolerance, adjust the latching bolt if possible, or replace latching bolt if necessary.

- After adjustment or replacement repeat this step.
- Record the measurements and any findings on the execution report in Appendix B.

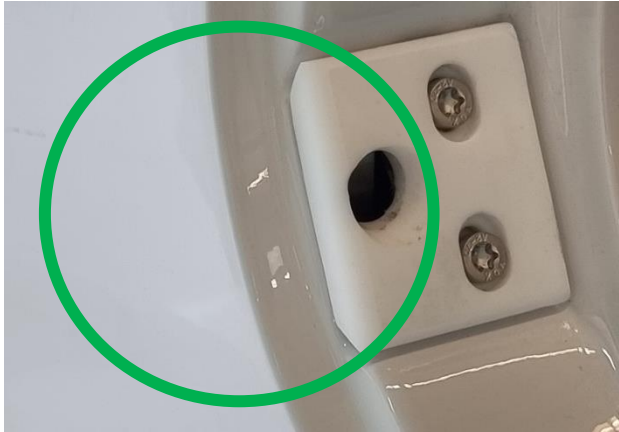
<p>Front</p>

24	<p>Data Collection: Inspect the door frame in the area around the front and rear latching bolts for damage.</p> <p>Record any damage on the execution report in Appendix B.</p> <div style="text-align: center;">
