MANDATORY SERVICE BULLETIN

MSB 42-149

MSB 42NG-095

Actions to prevent Passenger Door Separation: Installation of Placards, AFM Procedure update and Inspection/Data Gathering.

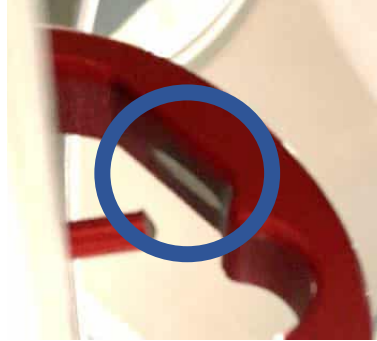
- 6 Examine the Safety Hook for signs of wear, corrosion and poor condition:
- Record the finding on the execution report in Appendix B.
 - There must be no deformation or cracks.
 - Pay particular attention to the contact area of the Actuation Pin.
 - Grooves in the Safety Hook must be less than 2 mm deep.

Replace Safety Hook, if

- any of the Safety Hook dimensions measured in this step are not within the given tolerances, or
- corrosion is found, or
- deformation, grooves, ridges or steps.

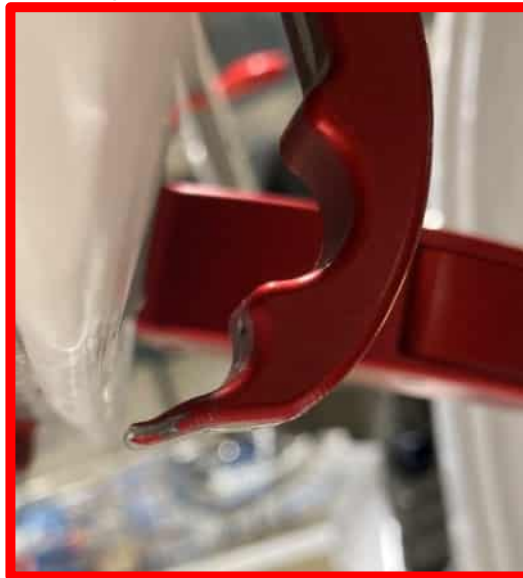
- Pay particular attention to the hook end of the Safety Hook.
 - The hook end must not be bent.
 - Not acceptable:

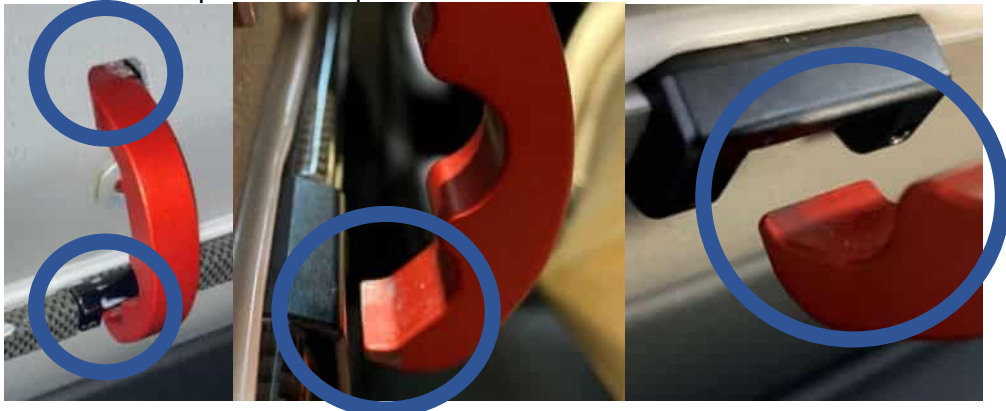
- There must be no corrosion on the contact area to the Retaining Bracket.
- Examples of acceptable conditions:

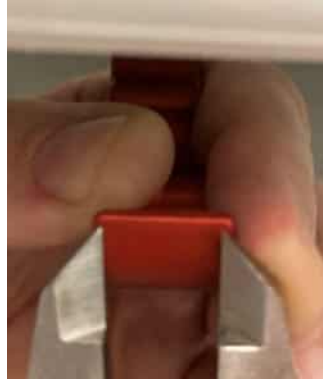
- Examine the tip of the Safety Hook for wear:
 - Wear of edges of Safety Hook:
 - The width of the tip of the Safety Hook must be greater than 10.5 mm.

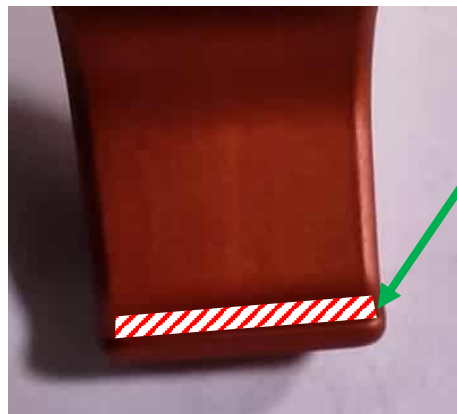
- The engaging surface of the Safety Hook is the flat surface at the tip of the Safety Hook.
 - It must be free from steps and ridges.
 - Scratches or uniform wear of surface protection are permitted.

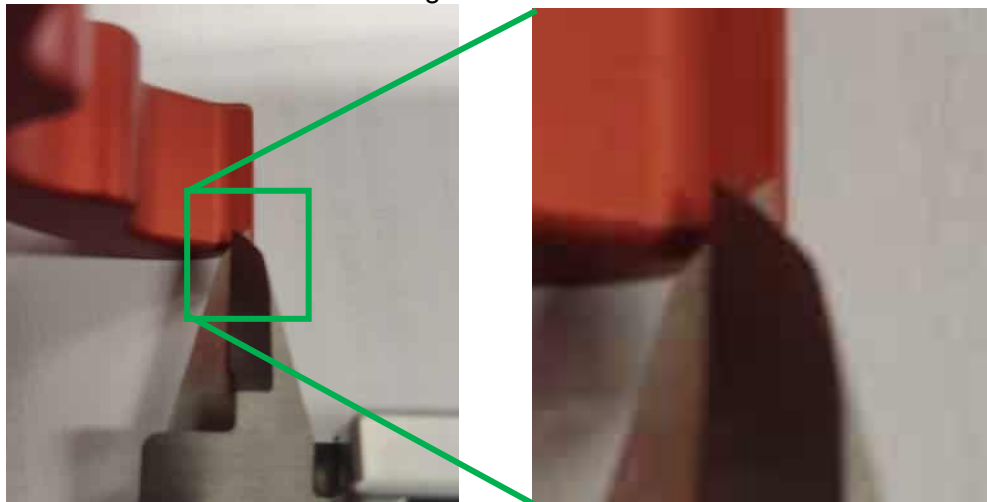
- Measure the width of the engaging surface.
 - The width must be greater than 1.5 mm.

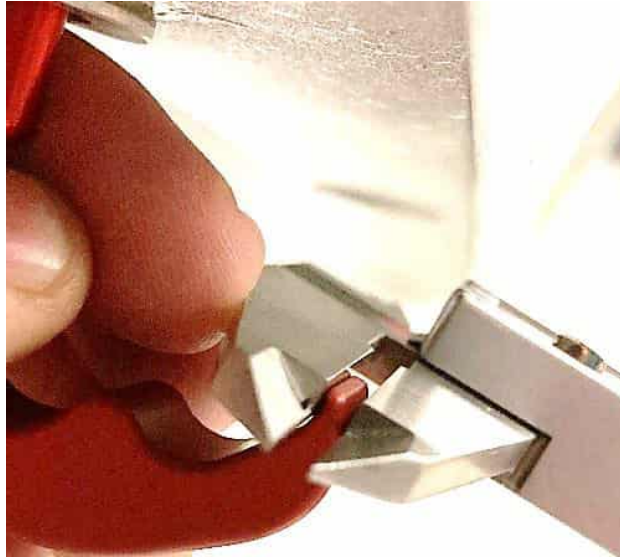
- Measure the maximum thickness of the Safety Hook at the location of the engaging surface, perpendicular to the engaging surface.
 - The thickness must be greater than 2.5 mm.
 - The maximum variation of measured thickness over the width of the Safety Hook must be less than 0.2 mm.

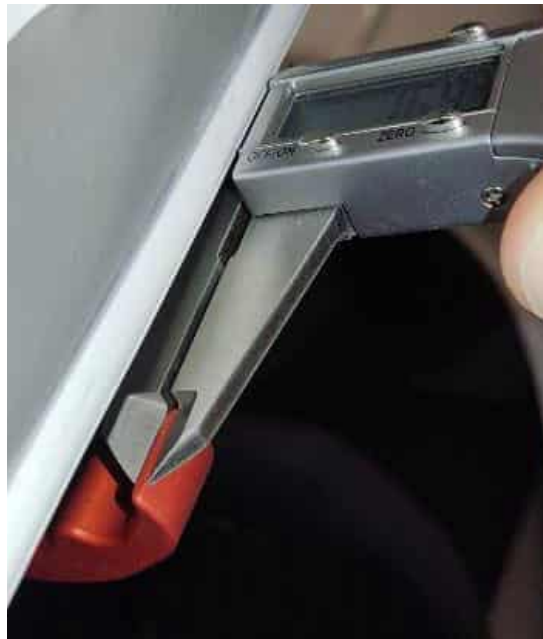
- Measure the minimum thickness of the Safety Hook at the location of the engaging surface, perpendicular to the engaging surface.
 - The minimum thickness must be greater than 1.5 mm.
 - The maximum variation of this value over the whole width must be less than 0.2 mm.

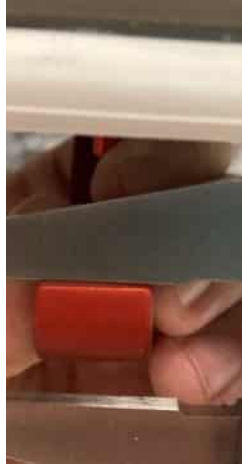
- The edge of the engaging section of the Safety Hook that is facing towards the Retaining Bracket must be free from ridges.

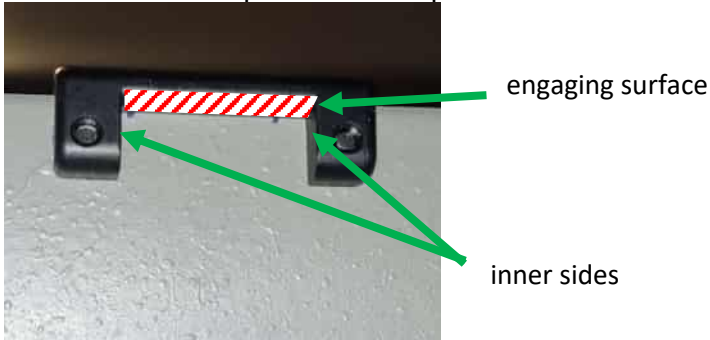
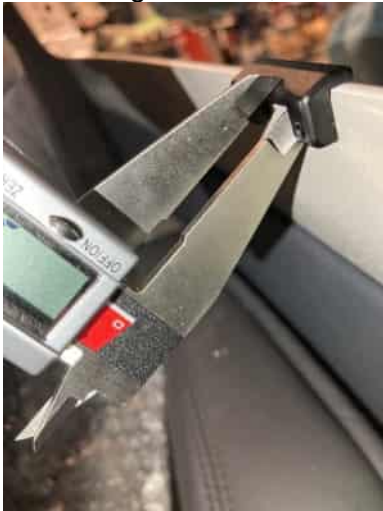
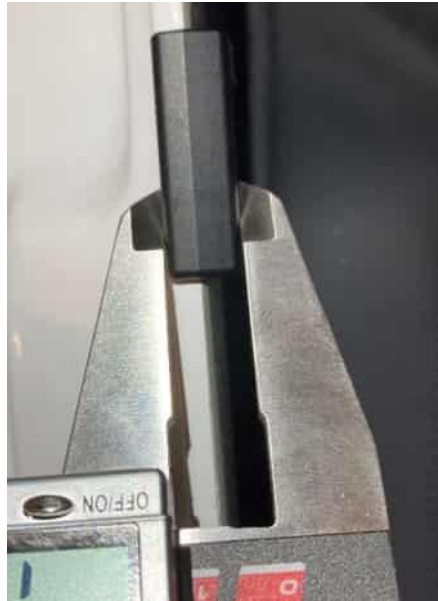
| 10 | <p>Examine the Retaining Bracket for signs of wear, corrosion and poor condition.</p> <ul style="list-style-type: none"> • There must be no corrosion on the Retaining Bracket. • Wear at the inner sides of the Retaining Bracket: maximum 0.5 mm per side. • The engaging surface of the Retaining Bracket and the edge of the engaging surface facing the Retaining Bracket must be free from steps and ridges. • Scratches or uniform wear of surface protection are permitted. <ul style="list-style-type: none"> • The thickness of the Retaining Bracket measured perpendicular to the upper surface must be greater than <ul style="list-style-type: none"> ○ 4 mm (for Retaining Bracket DA4-5200-00-69_02 (extended with undercut), or ○ 6 mm (for all other Retaining Brackets, refer to Step 8). <ul style="list-style-type: none"> • The width of the Retaining Bracket (measured i.a.w. picture below) must be greater than 10 mm. <ul style="list-style-type: none"> ○ Variation of the width over the whole length of the Retaining Bracket must be less than 0.2 mm. |

Replace the Retaining Bracket, if:

- any of the Retaining Bracket dimensions are not within the given tolerances, or
- if corrosion is found, or
- the wear limit is exceeded, or
- steps or ridges are found.

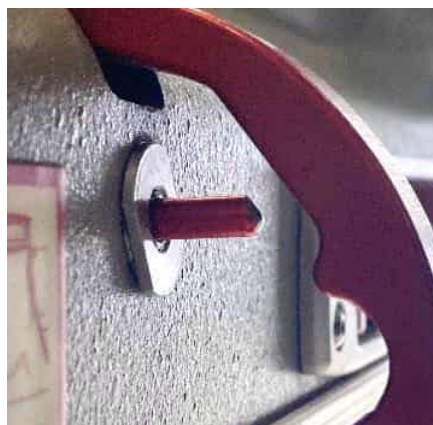
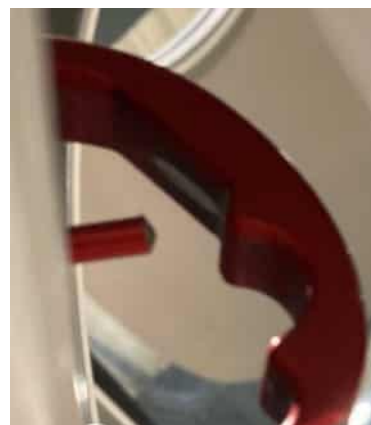
- 13 Examine the Safety Hook Actuation Pin for corrosion, wear and poor condition.
- There must be no corrosion on the sliding surfaces.
 - If corrosion is found, replace corroded parts.
 - The play of the Actuation Pin in the bushing must be less than 1 mm.
 - If the play is greater than 1 mm, replace the affected parts.
 - Record any findings and replaced parts on the execution report in Appendix B.

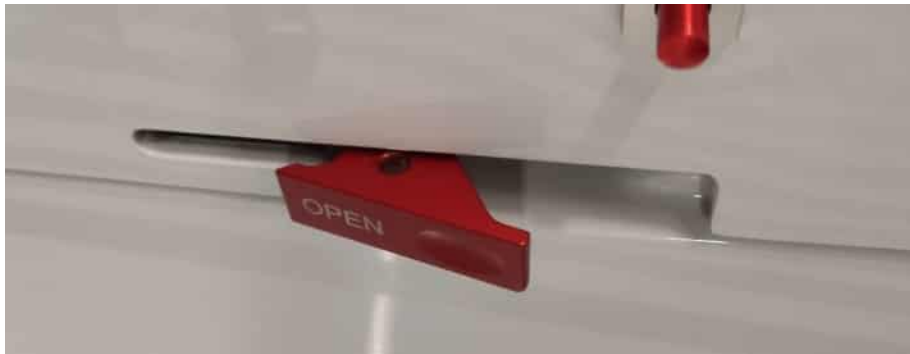
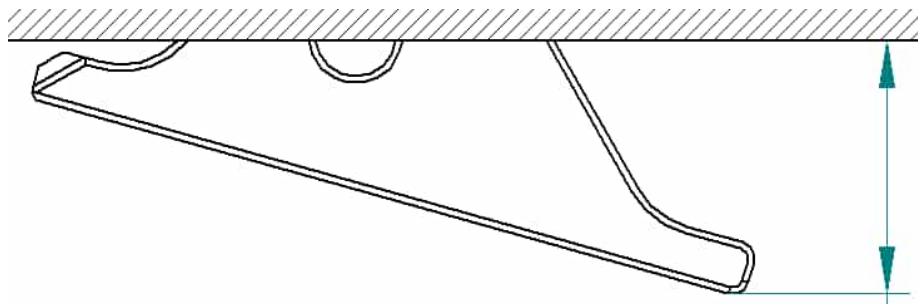
18 If MÄM 42-097 is installed (refer to step 15), examine the condition of the gas spring of the latching mechanism:

- Open the Passenger Door.
- Move the Passenger Door handle into unlatched position.
- Slowly move the Passenger Door handle towards the latched position and measure the distance at which the Passenger Door handle snaps into latched position by itself (measured at the outermost point of the lever, refer to sketch below).

- If the distance is less than 20 mm, replace the compression gas spring. Refer to AMM Section 52-10. Repeat this step after replacement.
 - If the distance is less than 20 mm after replacement of the gas spring, the cause is high friction in the latching system.
 - Examine the latching bolts according to step 22.
 - If the reason for high friction in the latching system cannot be found, replace the latching system i.a.w. AMM section 52-10.
 - Repeat this step after parts replacement.
- Record the measured distance and any replacements on the execution report in Appendix B.

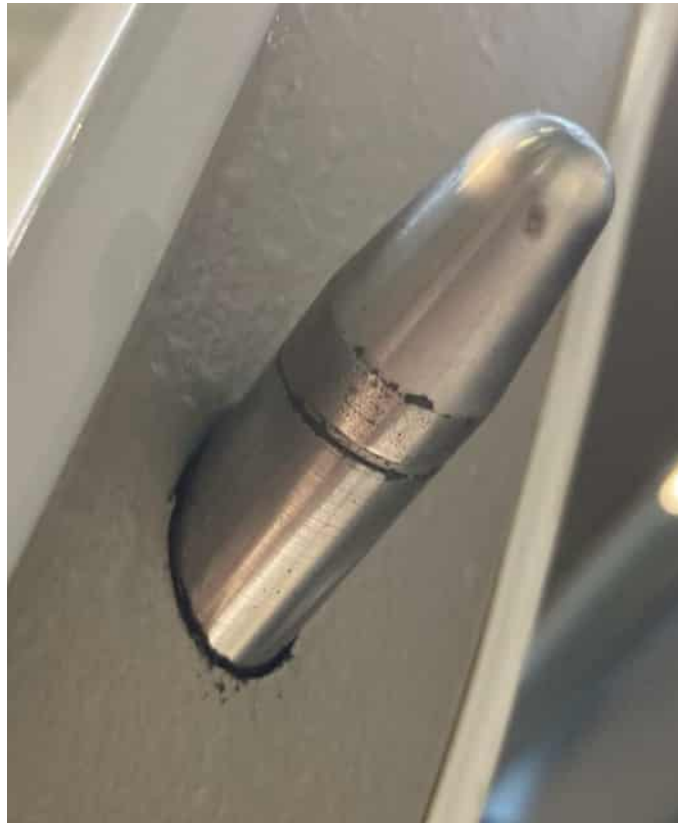
Example of a serviceable Latching Bolt

22 Examine the latching bolts of the Passenger Door for looseness, excessive play, wear, corrosion, and poor condition.

- It must not be possible to rotate the latching bolts by hand force.
- The radial play of the latching bolts must not exceed 0.8 mm at the tip of the latching bolts.
 - If the radial play exceeds 0.8 mm, contact Diamond Aircraft Industries GmbH.
- No sign of corrosion is allowed.
 - If signs of corrosions on the latching bolts are found, replace the latching bolts.
- No deformation (dents, bends, cracks) on the latching bolts is allowed.
 - If deformations of the latching bolts are found, replace the latching bolts.
- If parts are replaced, repeat this step.
- In case of doubt, contact DAI for instructions.
- Record any findings on the execution report in Appendix B.

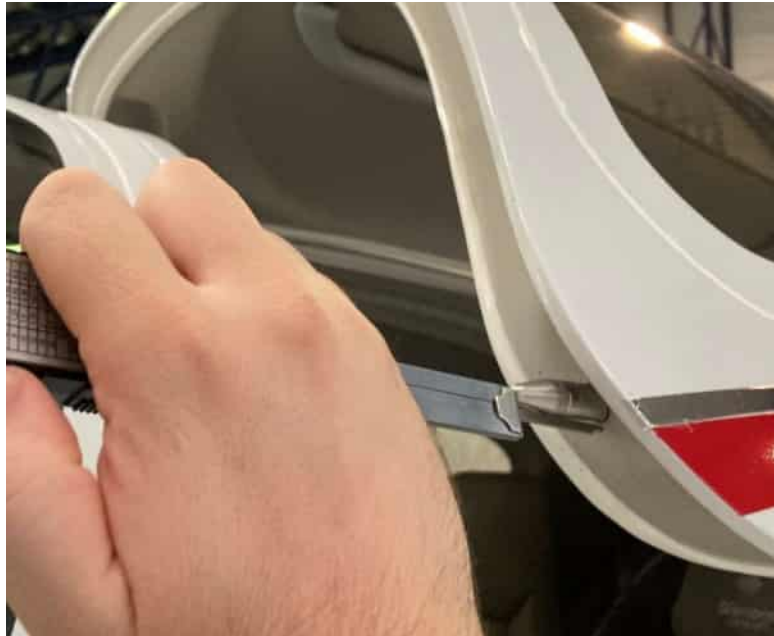
Front Latching Bolt

- Measure the extension length at the bottom of the front and rear latching bolts in mm. Refer to pictures below.
 - The front latching bolt extension length must be 40 ± 2 mm.

- If the extension length is out of tolerance, adjust the latching bolt if possible, or replace latching bolt if necessary.
 - After adjustment or replacement repeat this step.

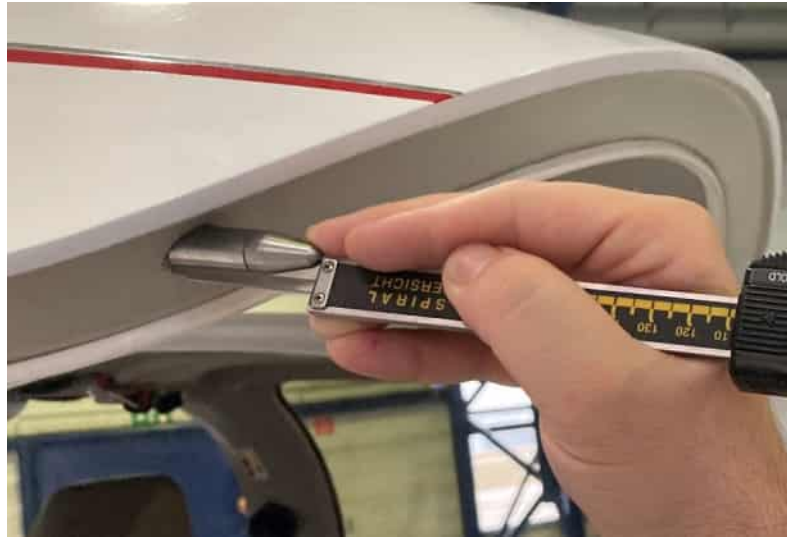
Rear Latching Bolt

- If MÄM 42-687 is **not** installed, the rear latching bolt extension length must be 40 ± 2 mm.
 - If the extension length is out of tolerance, adjust the latching bolt if possible, or replace latching bolt if necessary.

- After adjustment or replacement repeat this step.
 - If MÄM 42-687 is installed, the rear latching bolt extension length must be 44 ± 1 mm.
 - If the extension length is out of tolerance, adjust the latching bolt if possible, or replace latching bolt if necessary.
