# RECOMMENDED SERVICE BULLETIN

## RSB 42NG-098

Type: DA 42 NG  
Serial numbers: 42.N272, 42.N274, 42.N523,  
42.N525 through 42.N527,  
42.N529, 42.N531 through 42.N544,  
42.N546, 42.N547

Replacement of double check valve of main hydraulic manifold assy.

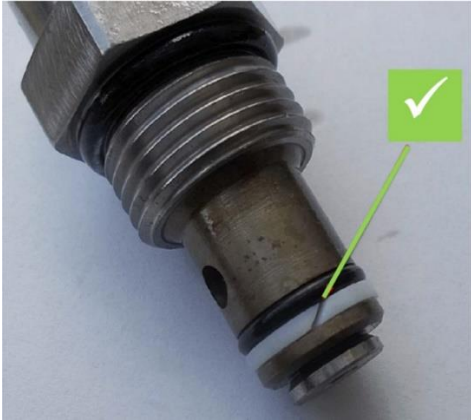
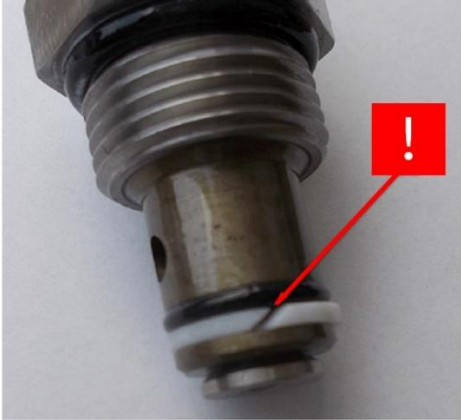
| 8 | <p>Examine the new valve for contamination.</p> <p>Examine the white PTFE ring for improper seat or protrusion</p> <p style="text-align: center;"><b>CAUTION</b></p> <p style="text-align: center;">Improperly seated and protruding rings can be sheared off during installation.</p> <div style="display: flex; justify-content: space-around;"></div> |

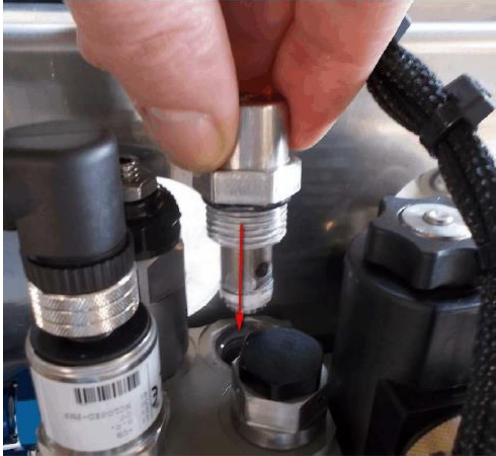
| 11 | <p>Torque the check valve with 20 Nm.</p> <p><b>CAUTION</b></p> <p>When the O-rings enter the tapered section of the thread, increased resistance is normal. Continue screwing the valve with the socket. A consistent torque of 4-6 Nm until the mechanical hard stop is normal. If higher resistance is observed, the support ring may have protruded and been sheared off. In this case, unscrew and check the check valve again.</p> |
