SERVICE INFORMATION NO. SI 42NG-035

Austro Engine Mandatory Service Bulletin MSB-E4-014/2
ATA-Code: 73-10

MANDATORY SERVICE BULLETIN

Replacement of the Fuel Return Line and Banjo Fitting

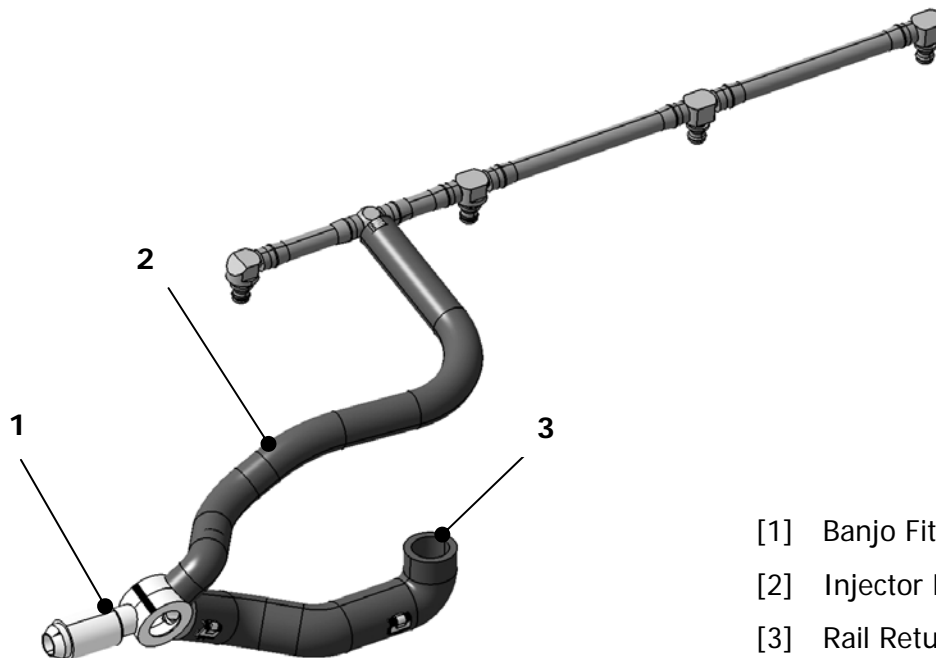
- [1] Banjo Fitting
- [2] Injector Return Line
- [3] Rail Return Line

1. "Removal of the Injector Cover" according to Maintenance Manual E4.08.04, chapter 85-00-11.
2. Replacement of the Injector Return Line and Banjo Fitting according the following steps:

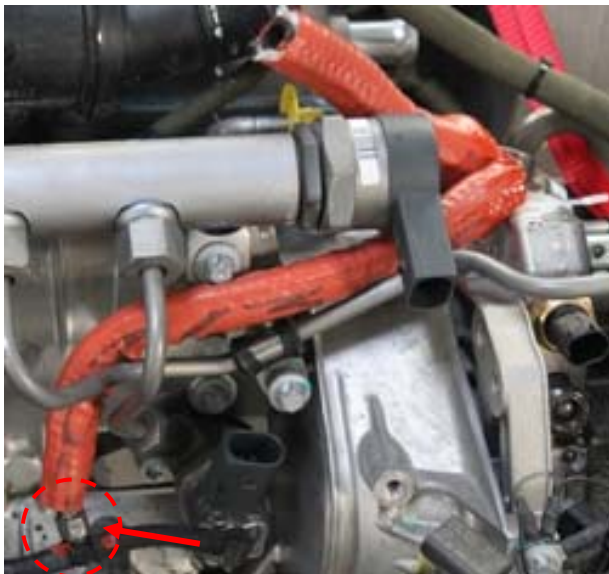
Step 15

Service experience showed cracks in the fuel return line after about 600 engine operating hours due to inappropriate routing which could lead to fuel leakage.

Route the hose as shown and connect the Injector Return Line [5] with new clamp.
