NO. SI 42NG-040

Austro Engine Mandatory Service Bulletin No. MSB-E4-007/3
ATA-Code: 71-00

MANDATORY SERVICE BULLETIN

Replacement of Waste Gate Controller

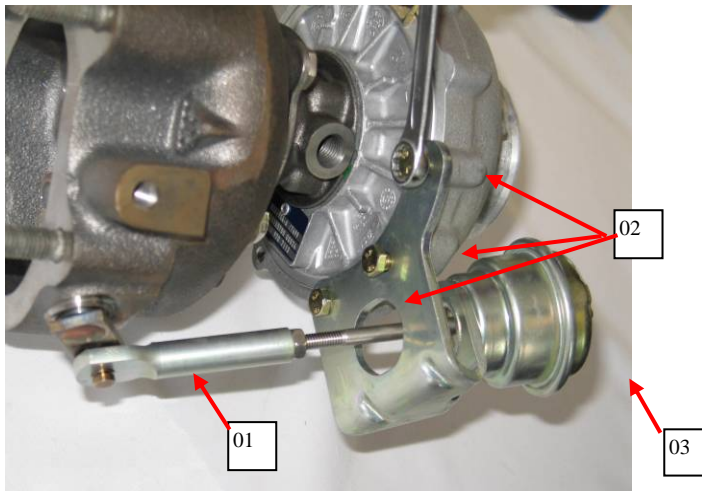
There have been cases where the rod of the Waste Gate Controller cracked. Therefore replacement with latest Waste Gate Controller design is necessary.

1. Disconnect Hose at the top of the Waste Gate Controller
2. Remove three M6 Bolts [02]
3. Remove Circlip [01]
4. Disconnect rod from waste gate lever and remove waste gate controller [03]

1. Install the three M6 Bolts [02] and torque them with 7 Nm
2. Attach external pump to the top of the Waste Gate Controller and apply pressure till the rod starts to move
3. Connect rod to waste gate lever
4. Adjust Waste Gate Controller according to Engine Maintenance Manual E4.08.04, Chapter 81-00-32.

Note: For fixing of the rod on the waste gate lever use new circlip.
