SERVICE INFORMATION

NO. SI 42NG-050

EASA Airworthiness Directive No. 2013-0025R1 and Austro Engine Mandatory Service Bulletin MSB-E4-007/4

Replacement of Waste Gate Controller

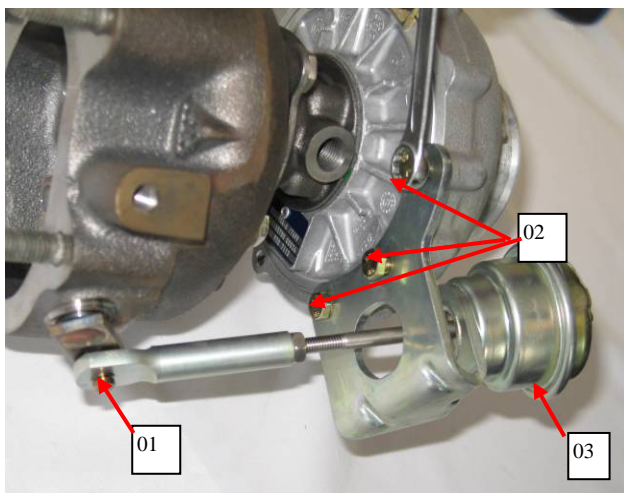
There have been cases where the rod of the Waste Gate Controller cracked. Therefore replacement with latest Waste Gate Controller design is necessary.

1. Disconnect Hose at the top of the Waste Gate Controller
2. Remove three M6 Bolts [02]
3. Remove Circlip [01]
4. Disconnect rod from waste gate lever and remove waste gate controller [03]

1. Install the three M6 Bolts [02] and torque them with 7 Nm
2. Attach external pump to the top of the Waste Gate Controller and apply pressure till the rod starts to move
3. Connect rod to waste gate lever
4. Adjust Waste Gate Controller according to Engine Maintenance Manual E4.08.04, Chapter 81-00-32.

Note: For fixing of the rod on the waste gate lever use new circlip.
