SERVICE INFORMATION

No. SI 42NG-057/1

GARMIN Terrain Data Alert No. 1351 Revision B

Terrain Data Alert 1351

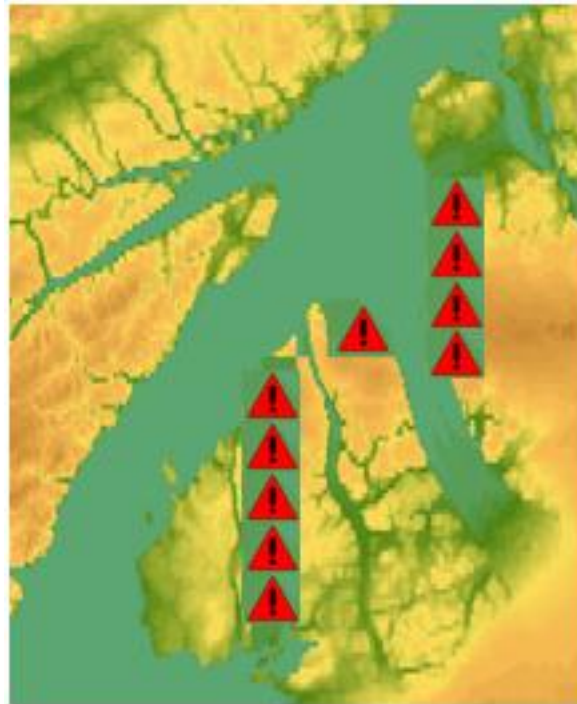
= Affected Area

Refer to the figure below. The affected area is within a 55nm radius centered around N80° 50', W62° 30' located in the northwest region of Greenland.

The nearest airport (CYLT) is 60 nm north of the affected area.

Anomalies may prevent TAWS/Terrain alerts and display an invalid terrain representation when using Synthetic Vision Technology (SVT) in the affected area.

Pilots should utilize extra caution and maintain awareness of the surrounding terrain when flying in northwest Greenland.

This issue will be corrected in a future cycle release. Refer to the [Areas of Degraded Terrain Database Performance](#) on the Garmin website for a list of resolved Terrain Database issues.
