SERVICE INFORMATION

No. SI 42NG-073/1

GARMIN Service Advisory No. 1514 Rev. B

SUBJECT: Potential Erroneous Lateral Guidance

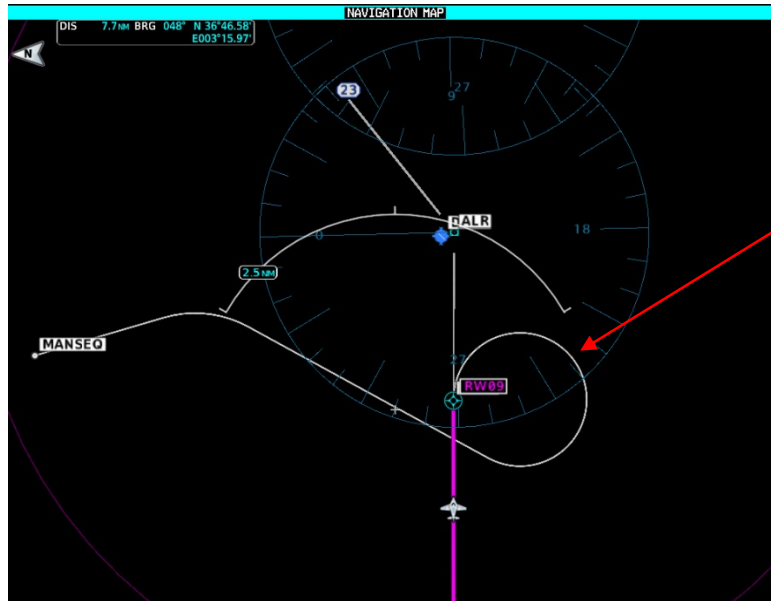
Flight management system may provide erroneous lateral guidance when navigating certain legs of a terminal procedure, including SID, STAR, instrument approach, and missed approach procedures. The final approach segment from the FAF to MAP is not affected.

This condition can occur when one procedure (SID, STAR, or instrument approach) is removed from an active flight plan and replaced with a different procedure within the same active flight plan. It may also occur if a SID and/or STAR is added to an active flight plan *after* an approach procedure has already been loaded within the same active flight plan.

The condition appears in the form of a circular leg drawn on the Navigation Map page to indicate a turn in the opposite direction and is added at the intersection of two procedure legs that are not associated with a FAF (see Figure 1).

Figure 1 – Erroneous Anticipated Turn (Circular Leg)

Monitor the Navigation Map page on the MFD when flying terminal procedures and always compare displayed flight path depictions with applicable published procedures. If this condition occurs, follow CDI course guidance manually and/or by using AFCS Heading Mode.
