SERVICE INFORMATION NO. SI 42NG-076

Austro Engine MSB-E4-020 Inspection of Gearbox Housing

MANDATORY SERVICE BULLETIN No. MSB-E4-020

Inspection of gearbox housing

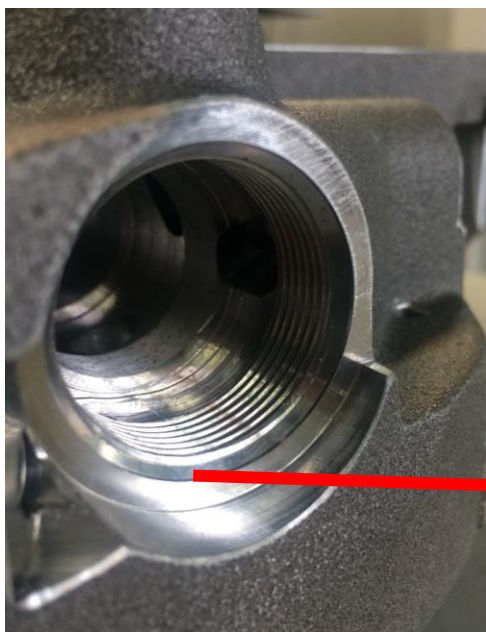
Fig. 1: Gearbox filter housing

3. Conduct a visual inspection for an existing burr at the end of the chamfer of the thread where the filter plug screw is installed. Compare to the example given below:

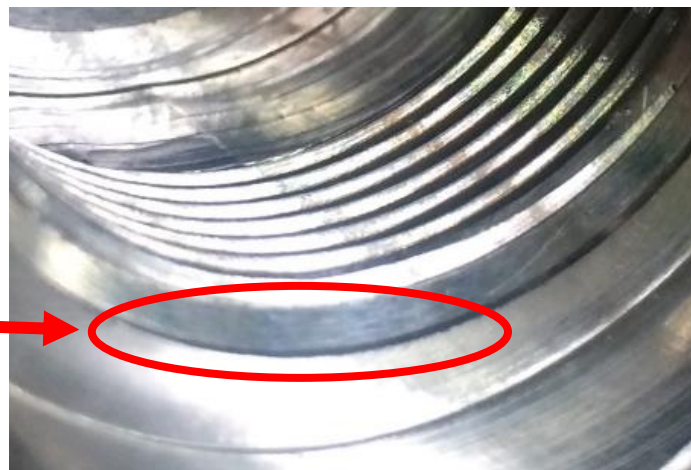
On few gearboxes a burr between the sealing surface and plane plug screw surface of the filter housing has been detected which could damage the O-ring. A damaged O-ring could lead to leakage between the sealing surface and the gearbox filter plug screw.

Fig. 2: Detail (burr detected - within the red oval)

If a burr is existing, the gearbox filter housing must be re-worked according to Work Instruction WI-MSB-E4-020 Rev.0.
