SERVICE INFORMATION

No. SI 42NG-078

GARMIN Service Advisory No. 1372 Rev. B

SUBJECT: Unavailable RNAV (GPS) approaches due to lack of VDA

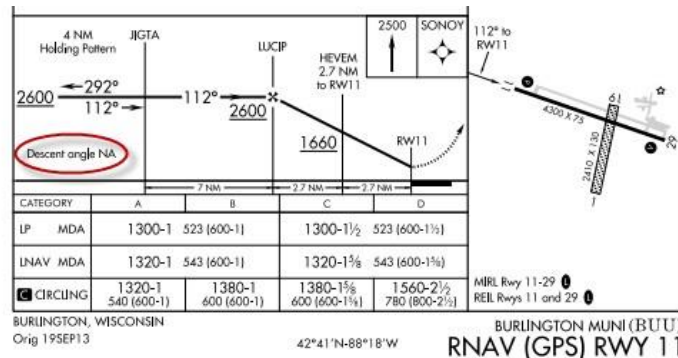
A limited number of RNAV (GPS) approaches, including all service levels, are unavailable for selection when the approach includes LP minima and also has no published vertical descent angle (VDA). See the example in Figure 1.

Figure 1: No Published Vertical Descent Angle (VDA) Example

- G1000, Cirrus Perspective, Embraer Prodigy, G950, and G900X GDU software versions 15.00 and later
- G2000, G3000, and G5000 GDU software versions 5.00 and later
- GNS 400W/500W Series main software versions 5.10 and later
- GTN 6xx/7xx Series main software versions 5.13 and later
