SERVICE INFORMATION NO. SI 42NG-086/2

Austro Engine Mandatory Service Bulletin No. MSB-E4-022 Rev. 3
ATA-Code: 71-00

MANDATORY SERVICE BULLETIN

No. MSB-E4-022/3
SUPERSEDES MSB-E4-022/2

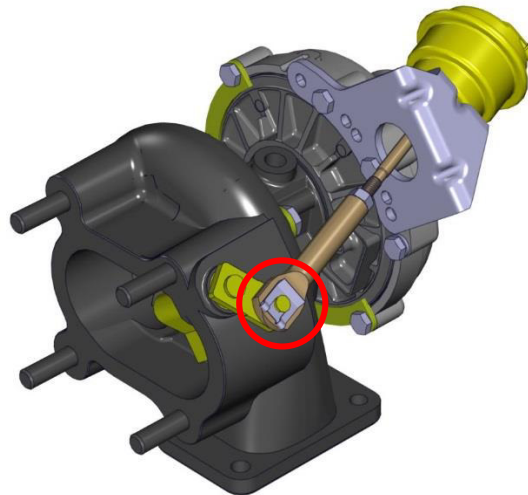
Figure 4: Waste Gate Circlip

Waste gate control rods with insufficient fatigue life have been identified. Failure of the waste gate control rod will lead to a partial loss of power.

1. Make sure MM-TR-MDC-E4-386 and MM-TR-MDC-E4-399 are inserted into the Maintenance Manual or a revision of the Maintenance Manual with the Temporary Revisions incorporated is used.
2. Replace the waste gate controller according to Maintenance Manual section 81-00-33.
3. Install a new the spring loaded circlip E4A-41-100-801. Refer to figure 4

1. Replace the waste gate controller according to Maintenance Manual section 81-00-33.
2. Install a new the spring loaded circlip E4A-41-100-801. Refer to figure 4.

1. Make sure MM-TR-MDC-E4-422 is inserted into the Maintenance Manual or a revision of the Maintenance Manual with the Temporary Revisions incorporated is used.
2. If not yet installed, install a new spring loaded circlip E4A-41-100-801. Refer to figure 4.
3. Install the waste-gate con-rod fail-safe bridge according to Maintenance Manual section 81-00-36 or install a waste-gate controller with the fail-safe con-rod bridge already installed. Make sure there is sufficient clearance to adjacent parts.
