SERVICE INFORMATION

NO. SI 42-227

NO. SI 42NG-092

Air Filter

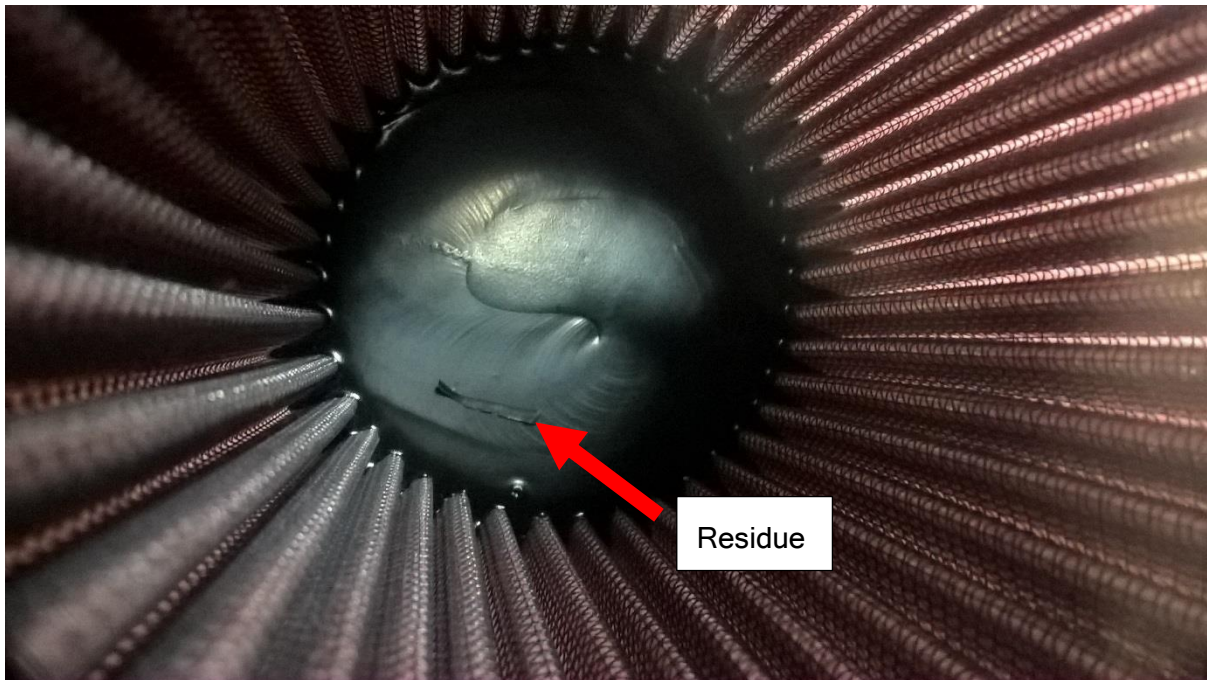
In the aircraft assembly line residue from manufacturing of the air filter was found in the charged air system.

Diamond Aircraft Industries GmbH advises maintenance personnel to inspect the bag in which new air filters are delivered and inspect also the inside of new air filters for loose residue from manufacturing.

Undetected residue may enter the charged air system and damage the turbocharger.

If loose residue is detected, remove it carefully prior to installation of the air filter.
If there is any doubt that the removal of the residue will affect the filter function or all residue cannot be removed, replace the air filter with a new air filter.
