SERVICE INFORMATION

NO. SI 42NG-116

Austro Engine Mandatory Service Bulletin No. MSB-E4-035
ATA-Code: 73-00

High Pressure Pump driving gear inspection

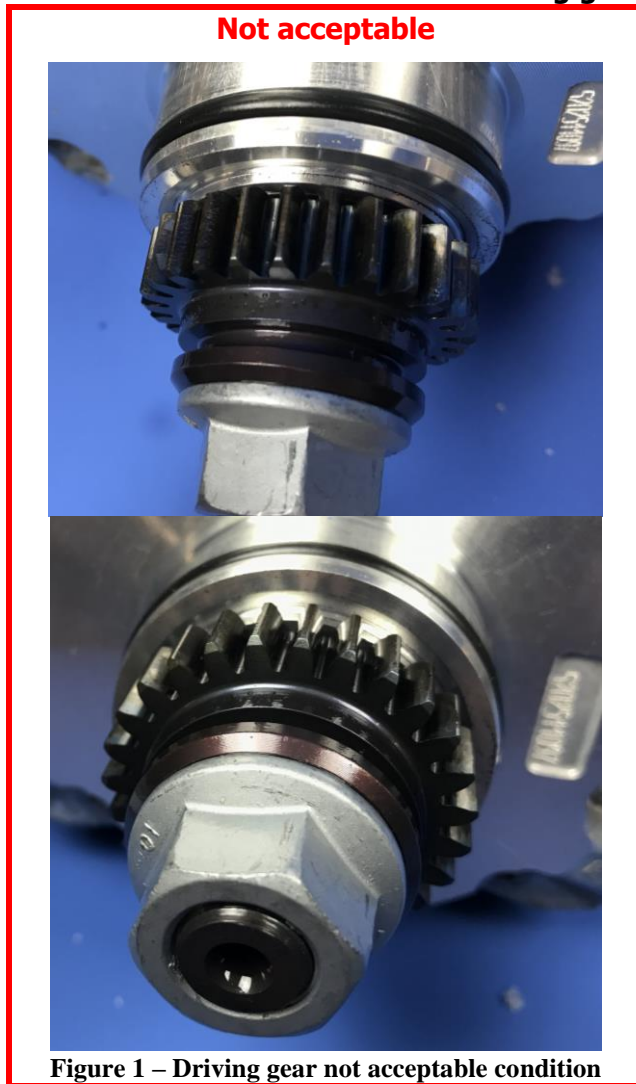
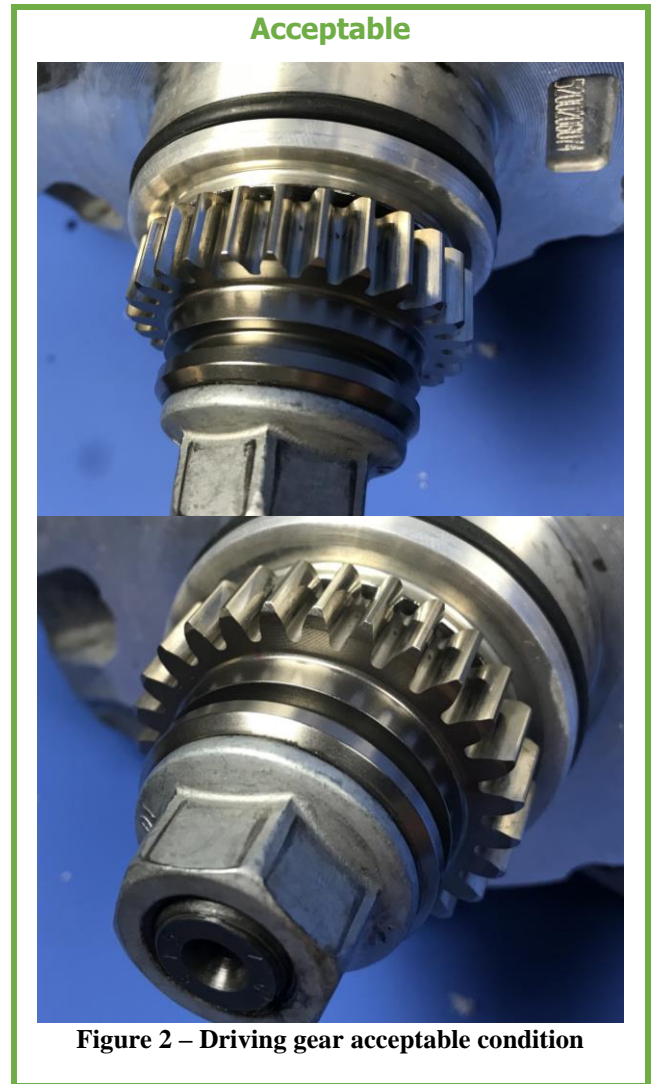
Table 1 - Driving gear colour check chart

1. Remove the HPP in accordance with the instruction provided in the Maintenance Manual, chapter 73-10-03 paragraph A
2. Clean the driving gear with Non-chlorinated brake cleaner (recommended product Manufacturer: Förch, Product ID.: R510)
3. Visually inspect the driving gear against colour criteria provided in the table 1. If acceptable criteria are not met, remove the camshafts according to the Engine Maintenance Manual chapter 85-30-00 subchapter 4A (a) - 4A (h), inspect the bushing of the inlet and outlet camshaft, take pictures and provide them to the Austro Engine support team. If the gear is in acceptable conditions, then proceed to step 5

■ **Note:** In case of doubt, contact Austro Engine providing pictures of the driving gear
