# **SERVICE INFORMATION**

## **NO. SI 42-242**

SIRS Service Information Letter No. SIRS/SIL-CE2-A25-01 Rev.02  
ATA-Code: 34-20

**No: SIRS/SIL-CE2-A25-01 Rev.02**

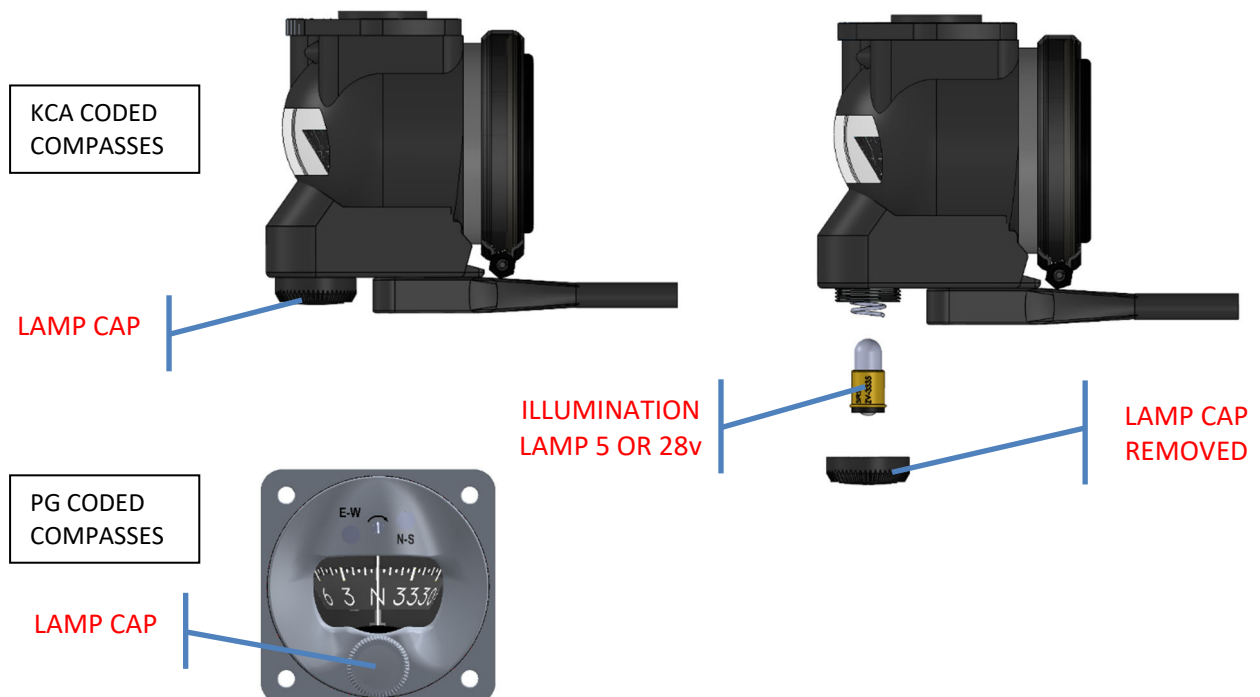
An occurrence\* has been reported to SIRS whereby the removal of an illumination lamp, **without immediate replacement**, has led to the local increase in temperature to adjacent compass components with subsequent plastic deformation. The problem will only occur with the power supply switched ‘**ON**’ and the illumination lamp **NOT Fitted**.

The absence of the replacement lamp will cause a decrease in circuit resistance and provide a 'short circuit', with potential power demand shown within table 1.0 below.

- A. **Always** include the correct lamp in the light assembly, specific to the compass part number (Functional or Non-Functional)

- B. If the lamp fails, **leave it in the assembly** until a replacement lamp can be installed.
- C. Leave the lamp assembled within the compass to prevent temperature increase.
- D. Should the compass be operated inadvertently, with the light assembly powered but without the lamp installed, power should be isolated immediately, as soon as this condition is identified. Before next flight, the compass should be removed from the aircraft and returned to SIRS.
- NOTE: SIRS are developing a permanent solution. A modified 'Lamp Cap Assembly' will be introduced by SIRS once approved to eliminate any further risk of 'short circuit' and 'localised increased temperature'.
- E. For further support **contact SIRS Navigation Ltd** to obtain additional information:
