# SERVICE INFORMATION

## NO. SI 42-247

Garmin Service Bulletin No. 22117 Rev. B

## SERVICE BULLETIN

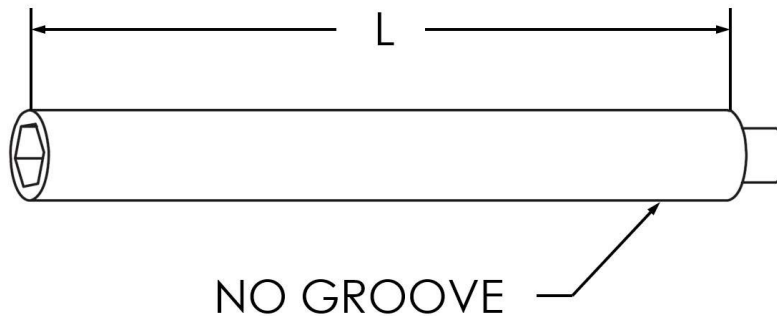
Figure 1 - 233-00075-01 and 233-00075-02 Cable Retention Pins

Both the -01 and -02 Cable Retention Pins have no grooves (See Figure 1). The -01 Cable Retention Pin is 1.48" long and the -02 is 1.60" long (See Figure 1).

In the event of the loss of the clutch retaining bolt, the output shaft drive pin may become partially disengaged causing the capstan to bind.

This Service Bulletin contains instructions to replace the cable retention pins with new longer cable retention pins to ensure the GSM servo gearbox capstan is free to rotate in the event that the clutch retaining bolt is not retained.
