SERVICE INFORMATION

NO. SI 42-249

NO. SI 42NG-142

GARMIN Service Bulletin No. 0736 Rev. C
ATA-Code: 34-00

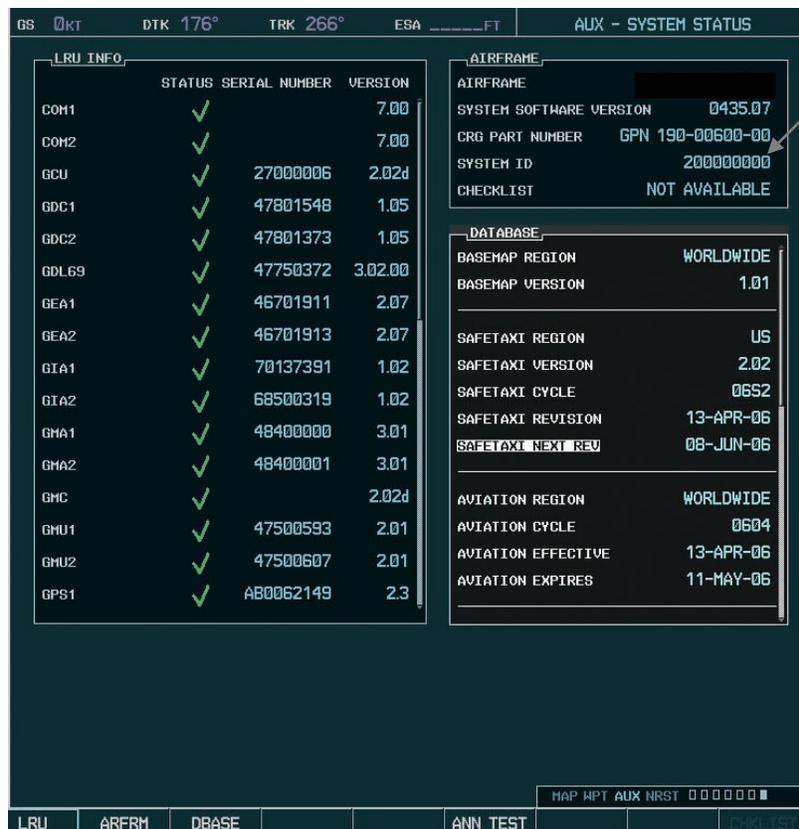
Figure 1. Example AUX – System Status Page

Garmin has identified an error associated with G1000 system software upgrades that sometimes results in an invalid System ID. An invalid System ID can be identified as either being “00000000” or “20000000”. The G1000 System ID can be verified on the AUX-System Status Page (Figure 1).

All GDU 1XXXs with a GDU software version of 7.00 or greater **and** a System ID of “00000000” or “20000000”. The G1000 System ID can be verified on the MFD AUX-System Status Page (Figure 1).

Use the G1000 System ID Tool (P/N 006-B0380-ZA) to change the G1000 System ID from “00000000” or “20000000” to a valid System ID by performing the following procedure:
