# MANDATORY SERVICE BULLETIN

## NO. MSB-42-006/1

Type: DA 42

Exchange of the Safety Walk on the Wing Stubs.

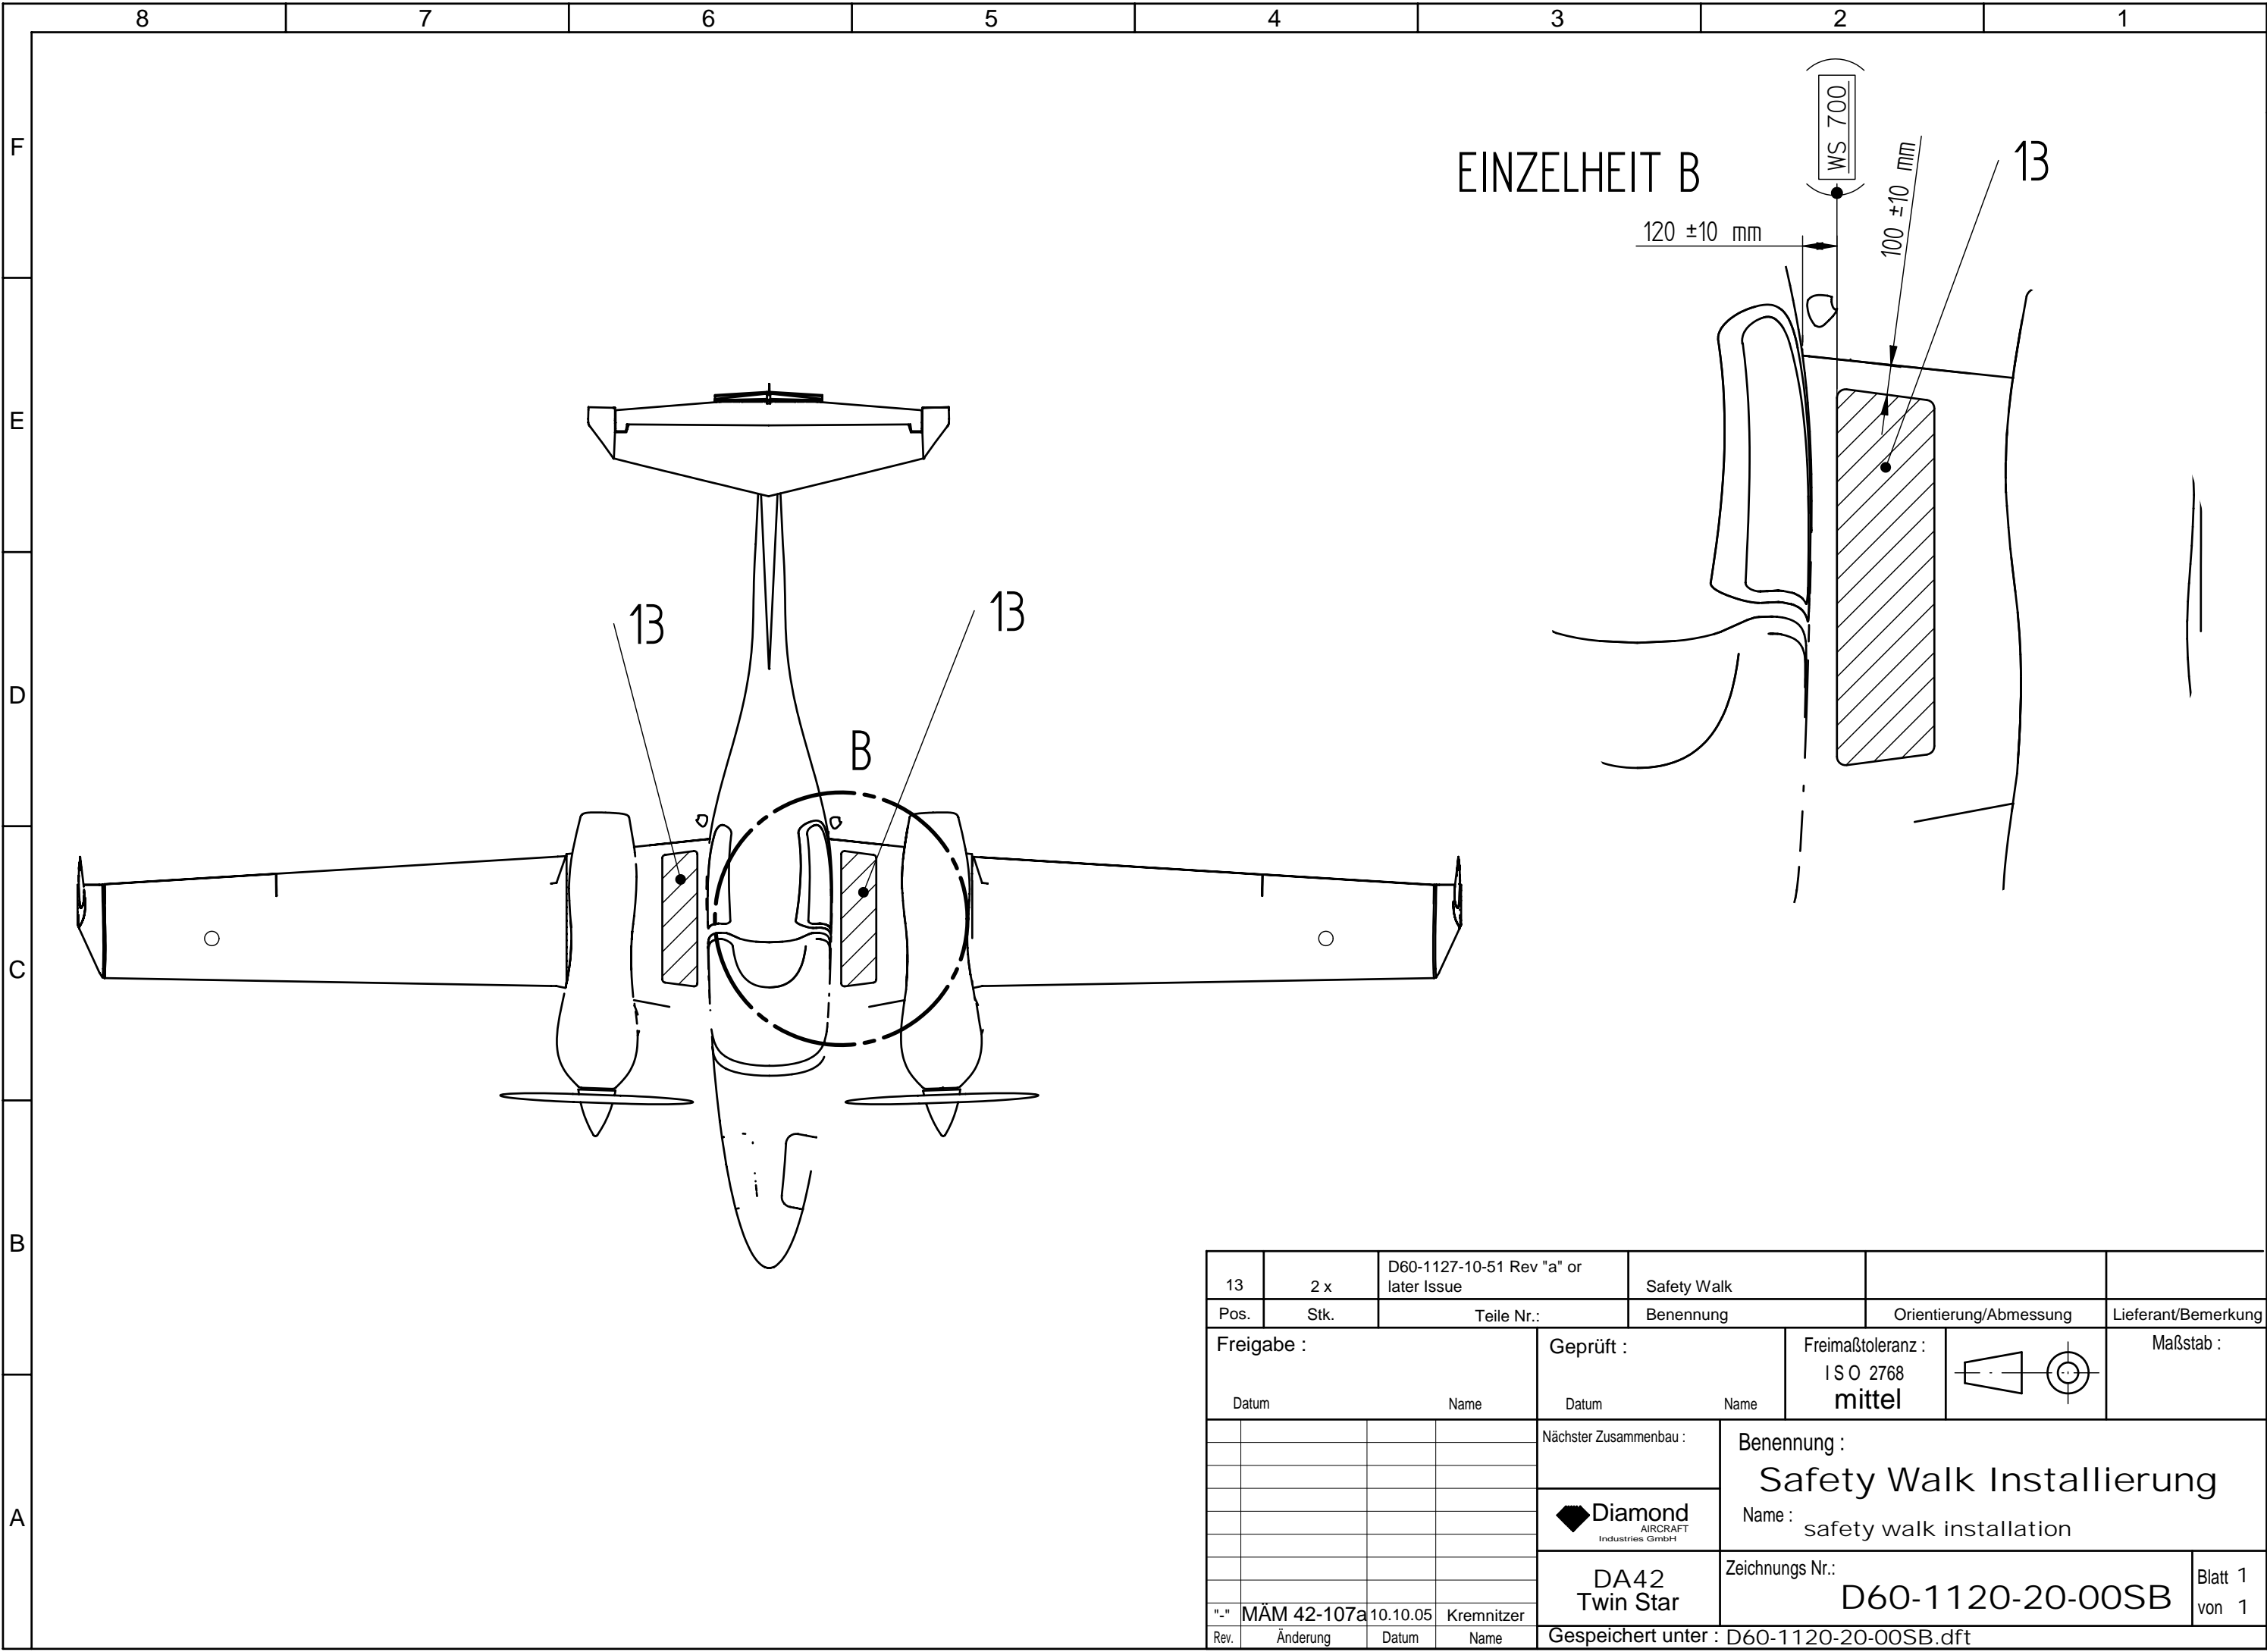
It has been found that the airplane fails to reach the one engine inoperative climb/descent data shown in the Airplane Flight Manual. In this context it has been determined, that the Safety Walk - 300 Series, color grey –coarse surface, has an adverse influence to the rate of climb – single engine operation. Replacement is necessary. In addition to that a Temporary Revision to the Airplane Flight Manual is

- a Remove Safety Walk Series 300, color grey – coarse surface (surface roughness equal to sandpaper with grid 40). For replacement refer to AMM, Chapter 11-00.
- b Install new Safety Walk D60-1127-10-51 Rev. “a” or later issue (surface roughness equal or finer than sandpaper grid 100) according to drawing D60-1120-20-00SB, latest effective revision. For replacement refer to AMM, Chapter 11-00.
- c Remove AFM-TR-MÄM-42-070, page 5-18a, and AFM-TR-MÄM-42-103, page 5-18b.
- d Mark AFM page 5-18 as superseded.
- e Incorporate Temporary Revision TR-MÄM-42-111/a into the AFM.
- f MSB 42-005 becomes obsolete with compliance to MSB 42-006/1 or later.
