# MANDATORY SERVICE BULLETIN

## NO. MSB-42-030/2

Check of return fuel line installation on Common Rail of TAE-Engine and replacement of Common Rail Banjo.

### „CHECK OF RETURN FUEL LINE INSTALLATION, REPLACEMENT OF COMMON RAIL BANJO“

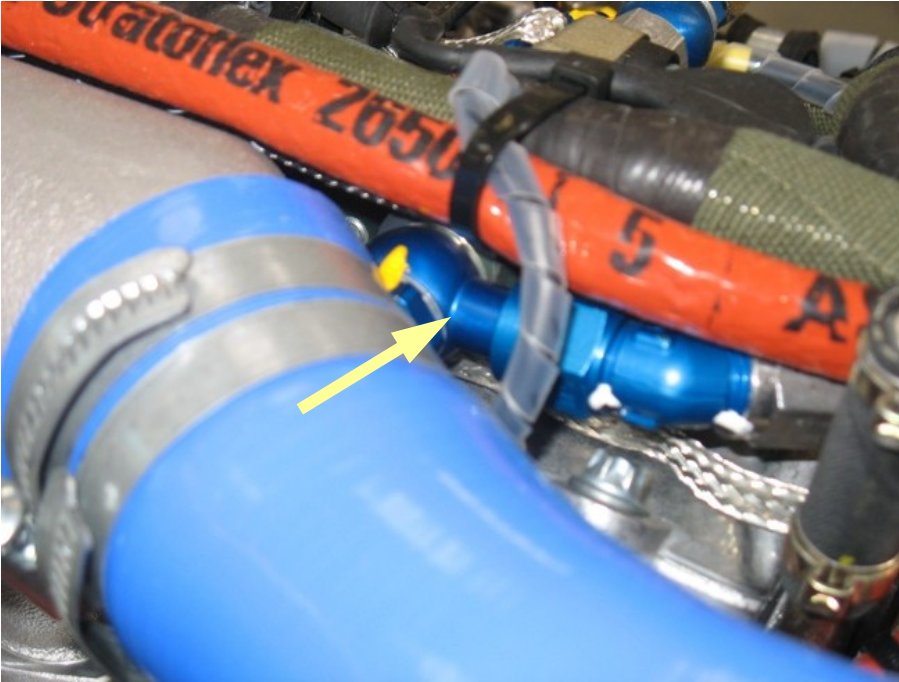
In some cases leakage occurred on the common rail banjo, where the return fuel line is connected to the common rail.

1	Remove upper cowling on LH engine according to AMM (refer to section 71-10)
2	Remove Common Rail according to Thielert Repair Manual RM-02-01, latest revision.
3	<p>Replace banjo, banjo bolt and gaskets on common rail according to Thielert Repair Manual RM-02-01, latest revision.</p>
