MANDATORY SERVICE BULLETIN

NO. MSB-42-031/1

I.5 Subject

Inspection and repair of MLG brace rib.

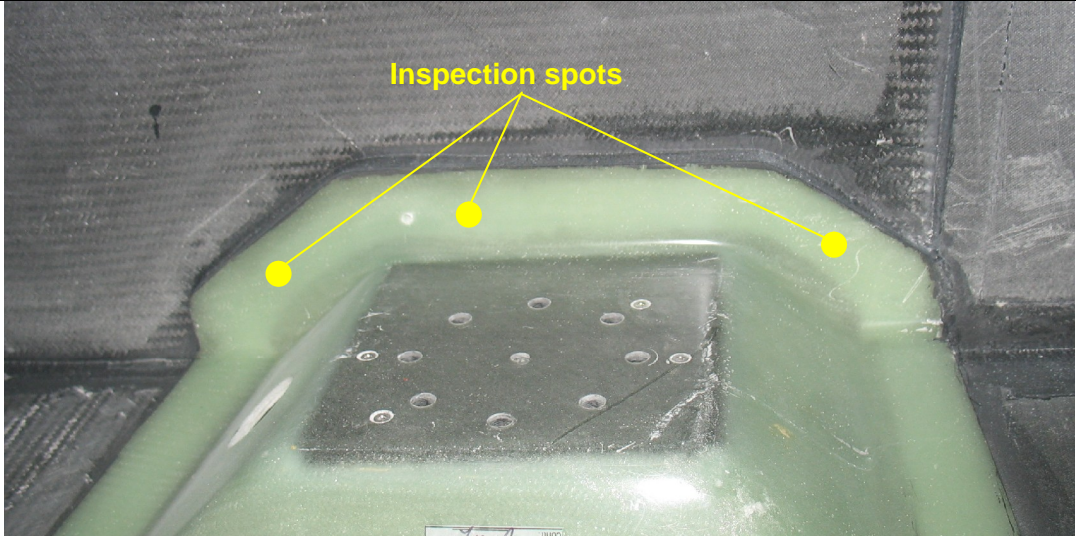
10. At the locations specified in the picture below (3 each side) carefully drill holes with a diameter of 4 mm (0.157", gauge 22 drill bit) and observe the following resistance behavior:

A) The drilling resistance develops as follows:

- a. The resistance is high due to the glass fiber laminate of the drag brace attachment rib.
- b. The resistance decreases due to the bonding paste.
- c. The resistance increases significantly due to the carbon fiber laminate of the upper shell of the center wing section.

B) The drilling resistance develops as follows:

- a. The resistance is high due to the glass fiber laminate of the drag brace attachment rib
- b. The resistance decreases due to the bonding paste
- c. The resistance first decreases significantly and then the drill hits the hard surface of the upper shell of the center wing section.

<p>Inspection spots</p> <p>LH side shown, RH side laterally reversed. (Brace pedestal not shown for clarity)</p>
11.	Remove the drill.
12.	<p>Inspect the hole and note one of the following conditions:</p> <p>A) The bottom of the drilled hole has the same color as the bonding paste</p> <p>B) The bottom of the drilled hole is black and glossy</p>
13.	<p>If in one of the inspection spots of items 10 and 12 the result B is detected proceed with item 14.</p> <p>Otherwise no repair is required. Fill inspection drill holes with bonding paste and proceed with item 21.</p>
14.	<p>Test fit repair ribs into place and mark out bonding area on both sides.</p> <p>Refer to drawing D60-5710-03-00RÄM and the labels on the repair brackets to identify the parts and the matching locations.</p>

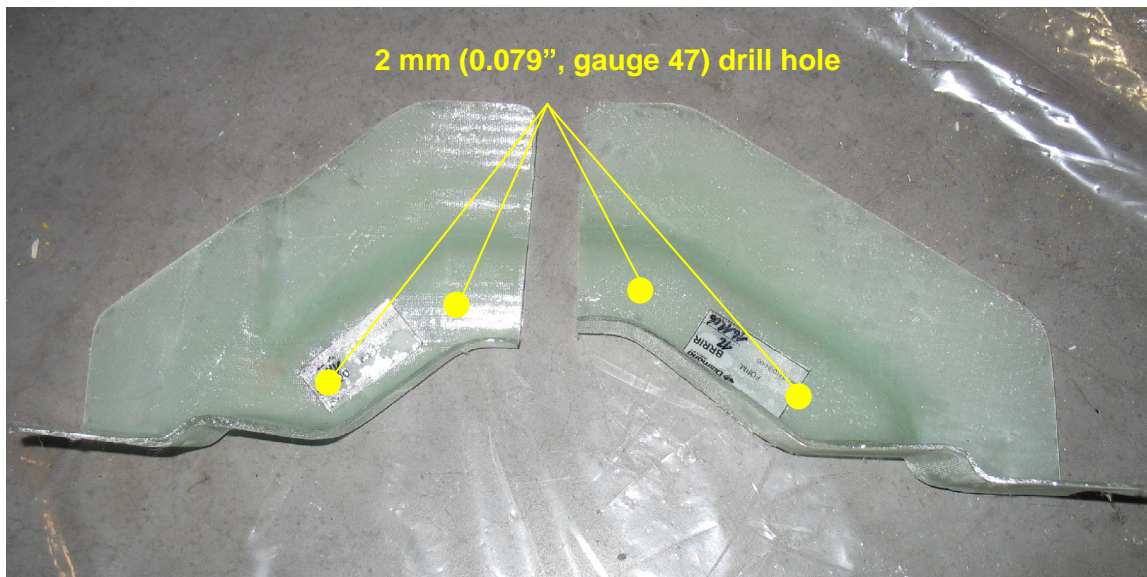
RH ribs shown, LH ribs laterally reversed.

15. Prepare the ribs:
Pre-drill ribs in marked locations with a 2 mm (0.079", gauge 47) drill.

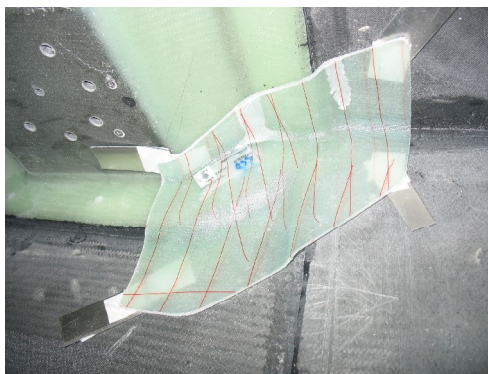
Picture for clarity only; do not extend the spacers too deep into bonding area

16. Drill a 2 mm (0.079", gauge 47) hole in the bonding flange of the faulty rib on both sides. Use the prepared repair ribs as a template. Use the 1.5 mm (0.059") spacers to account for the bonding paste (thickened resin) gap.

CAUTION: Measure thickness of the faulty bonding flange prior drilling of the holes. Do not damage the center wing shell sandwich!
